Access Compliance Report

Public Rights-of-Way

(Curb Ramps)

Intersection ID: 43113	Main Street: HELTON_WY	Cross Street: LAMAR_AV	Location: NE
ADA ID: ED0196A78D84	Ramp Type: Perp	Initial Pass/Fail: Fail	Overall Compliance: No
			Severity Score: 12.5

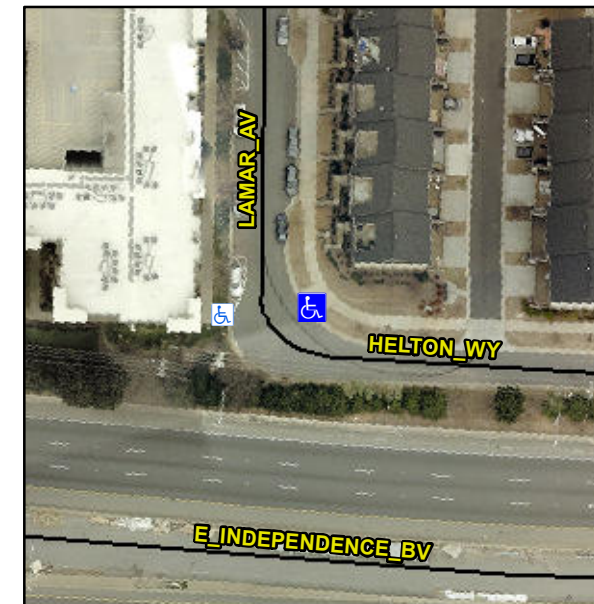
Not Found, R304.2.2

Compliance	Description	Data	Compliance	Description	Data
N/A	Ramp Length (in)	96.5	No	Ramp Slope (%)	8.7
Yes	Ramp Width (in)	60.0	Yes	Ramp XSlope (%)	1.6
N/A	Flare Type LT	N/A	N/A	Flare Type RT	N/A
N/A	Flare Slope LT (%)	N/A	N/A	Flare Slope RT (%)	N/A
N/A	Flare Traversable LT?	N/A	N/A	Flare Traversable RT?	N/A
N/A	Landing Length (in)	N/A	N/A	DWS Provided?	N/A
N/A	Landing Width (in)	N/A	N/A	DWS Contrast?	N/A
N/A	Landing Slope (%)	N/A	N/A	DWS Length (in)	N/A
N/A	Landing X Slope (%)	N/A	N/A	DWS Full Width?	N/A
N/A	Landing Curb? (Y/N)	N/A	N/A	DWS Offset (in)	N/A
N/A	Shared Landing?	N/A			
N/A	Gutter Ponding?	N/A	N/A	Gutter Slope (%)	N/A
N/A	Gutter Lip Ht (in)	0.5	N/A	Gutter X Slope (%)	N/A
N/A	Painted X Walk1?	No	N/A	Painted X Walk2?	N/A
	X Walk 1 Direction	To W		X Walk 2 Direction	N/A
N/A	X Walk 1 Width (in)	N/A	N/A	X Walk 2 Width (in)	N/A
	X Walk 1 Slope (%)	8.9		X Walk 2 Slope (%)	N/A
	X Walk 1 X Slope (%)	3.2		X Walk 2 X Slope (%)	N/A

Remove & Replace Entire Ramp.
