Access Compliance Report

Public Rights-of-Way

(Curb Ramps)

Intersection ID: 25907	Main Street: CHALLIS_HILL_LN	Cross Street: OLD_WELL_HOUSE_RD	Location:	N
ADA ID: ED0DF8DE6CAC	Ramp Type: PerpDiag	Initial Pass/Fail: Fail	Overall Compliance: No	Severity Score: 25

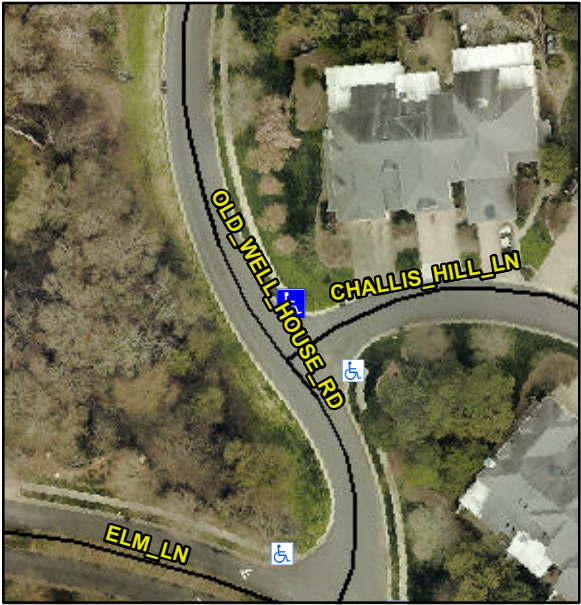
Possible Solutions:		Compliance	Description	Data
	Remove & Replace Curb Ramp With Two New Directional Ramps or Equivalent.		Yes	Ramp Length (in)	97.0
			N/A	Ramp Width (in)	48.0
			N/A	Flare Type LT	N/A
			N/A	Flare Slope LT (%)	N/A
			N/A	Flare Traversable LT?	N/A
			N/A	Flare Type RT	N/A
			N/A	Flare Slope RT (%)	N/A
			N/A	Flare Traversable RT?	N/A
			N/A	DWS Provided?	N/A
<p>Surveyor Notes:</p> <p>N/A</p> <p>PROW/ADA:</p> <p>R304.5.3</p>			N/A	DWS Contrast?	N/A
			N/A	DWS Length (in)	N/A
			N/A	DWS Full Width?	N/A
			N/A	DWS Offset (in)	N/A
			N/A	Gutter Ponding?	N/A
			N/A	Gutter X Slope (%)	N/A
			N/A	Painted X Walk1?	No
			N/A	X Walk 1 Direction	To W
			N/A	X Walk 1 Width (in)	N/A
			N/A	X Walk 1 Slope (%)	2.2
<p>Total Cost:</p> <p>\$ 3200.00</p>			N/A	X Walk 1 X Slope (%)	6.8
			N/A	Ramp inside XWalk1?	N/A
			N/A	Ramp inside XWalk2?	N/A

N/A	Road Slope (%)	4.3
			N/A	Road X Slope (%)	2.7
			N/A	Any Obstructions?	N/A
			N/A	Obstruction Type	
			N/A	Clear Space?	N/A
			N/A	Clear Space to XWalk (in)	N/A
			N/A	Storm Grate/Utility Hazard?	N/A
			N/A	Storm Grate/Utility Type	
			N/A	Surface Condition? (G/P)	Good
