## **Access Compliance Report Public Rights-of-Way** (Curb Ramps)

Intersection ID: N/A Main Street: NORTHLAKE CENTRE PY **Cross Street: N/A** Location: SW **ADA ID: ED0EA9F09391** Ramp Type: PerpDiag Initial Pass/Fail: Fail **Overall Compliance: No Severity Score:** 25

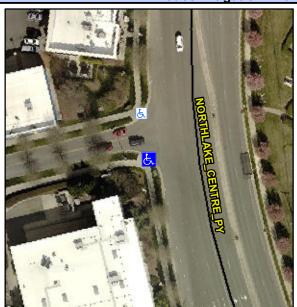
Compliance Description Data			Compliance Description		Data
N/A	Ramp Length (in)	43.0	Yes	Ramp Slope (%)	5.4
Yes	Ramp Width (in)	59.0	No	Ramp XSlope (%)	7.3
N/A	Flare Type LT	N/A	N/A	Flare Type RT	N/A
N/A	Flare Slope LT (%)	N/A	N/A	Flare Slope RT (%)	N/A
N/A	Flare Traversable LT?	No	N/A	Flare Traversable RT?	No
N/A	Landing Length (in)	N/A	N/A	DWS Provided?	N/A
N/A	Landing Width (in)	N/A	N/A	DWS Contrast?	N/A
N/A	Landing Slope (%)	N/A	N/A	DWS Length (in)	N/A
N/A	Landing X Slope (%)	N/A	N/A	DWS Full Width?	N/A
N/A	Landing Curb? (Y/N)	N/A	N/A	DWS Offset (in)	N/A
N/A	Shared Landing?	N/A			
N/A	Gutter Ponding?	N/A	N/A	Gutter Slope (%)	N/A
N/A	Gutter Lip Ht (in)	N/A	N/A	Gutter X Slope (%)	N/A
N/A	Painted X Walk1?	No	N/A	Painted X Walk2?	No
	X Walk 1 Direction	To E		X Walk 2 Direction	To N
N/A	X Walk 1 Width (in)	N/A	N/A	X Walk 2 Width (in)	N/A
	X Walk 1 Slope (%)	3.2		X Walk 2 Slope (%)	3.5
	X Walk 1 X Slope (%)	4.7		X Walk 2 X Slope (%)	2.4

N/A	Ramp inside XWalk1?	N/A	N/A	Ramp inside XWalk2?	N/A
	Road Slope (%)	3.8	N/A	Clear Space?	N/A
	Road X Slope (%)	2.4	N/A	Clear Space to XWalk (in)	N/A
N/A	Any Obstructions?	N/A	N/A	Storm Grate/Utility Hazard?	N/A
	Obstruction Type			Storm Grate/Utility Type	
		N/A			N/A
			Yes	Surface Condition? (G/P)	Good

Possible Solutions: Remove & Replace Curb Ramp Wit **Two New Directional Ramps or** Equivalent. Surveyor Notes: N/A PROW/ADA:

Not Found, R304.5.3
