Access Compliance Report

Public Rights-of-Way (Curb Ramps)

Intersection ID: 10942	Main Street: S I-77 EXIT 10B RA	Cross Street: N/A	Location: S
ADA ID: ED2BB128D568	Ramp Type: BlendTrans2	Initial Pass/Fail: Fail	Overall Compliance: No
Severity Score: 8.75			
Codes/Mitigation Info/Possible Solution		Field Measurements/Component Compliance

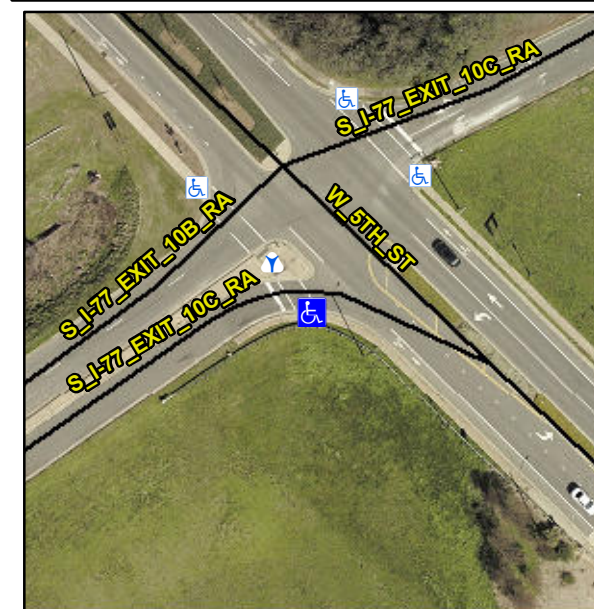
Not Found, R304.5.1

Compliance	Description	Data	Compliance	Description	Data
N/A	Ramp Length (in)	48.0	Yes	BlendTrans Slope (%)	2.3
No	Ramp Width (in)	47.5	Yes	BlendTrans XSlope (%)	1.0
N/A	Flare Type LT	N/A	N/A	Flare Type RT	N/A
N/A	Flare Slope LT (%)	N/A	N/A	Flare Slope RT (%)	N/A
N/A	Flare Traversable LT?	N/A	N/A	Flare Traversable RT?	N/A
N/A	Landing Length (in)	N/A	N/A	DWS Provided?	N/A
N/A	Landing Width (in)	N/A	N/A	DWS Contrast?	N/A
N/A	Landing Slope (%)	N/A	N/A	DWS Length (in)	N/A
N/A	Landing X Slope (%)	N/A	N/A	DWS Full Width?	N/A
N/A	Landing Curb? (Y/N)	N/A	N/A	DWS Offset (in)	N/A
N/A	Shared Landing?	N/A			
N/A	Gutter Ponding?	N/A	N/A	Gutter Slope (%)	N/A
N/A	Gutter Lip Ht (in)	N/A	N/A	Gutter X Slope (%)	N/A
N/A	Painted X Walk1?	No	N/A	Painted X Walk2?	Yes
	X Walk 1 Direction	To NE		X Walk 2 Direction	To NW
	X Walk 1 Width (in)	N/A		X Walk 2 Width (in)	112.0
	X Walk 1 Slope (%)	4.3		X Walk 2 Slope (%)	3.0
	X Walk 1 X Slope (%)	1.7		X Walk 2 X Slope (%)	3.0

N/A	Ramp inside XWalk1?	N/A	N/A	Ramp inside XWalk2?	Yes
	Road Slope (%)	0.9		Clear Space?	N/A
	Road X Slope (%)	4.2	N/A	Clear Space to XWalk (in)	N/A
N/A	Any Obstructions?	N/A	N/A	Storm Grate/Utility Hazard?	N/A
	Obstruction Type			Storm Grate/Utility Type	
		N/A			N/A
			Yes	Surface Condition? (G/P)	Good
			No	Curb Slope (%)	9.8

Remove & Replace Curb Ramp With Two New Directional Ramps or Equivalent.

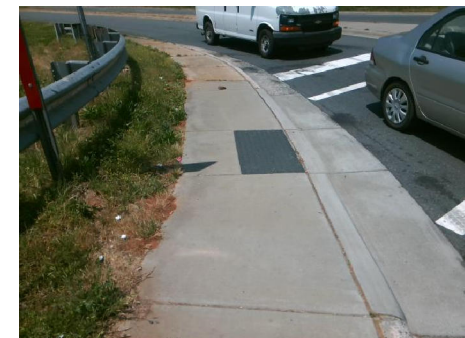
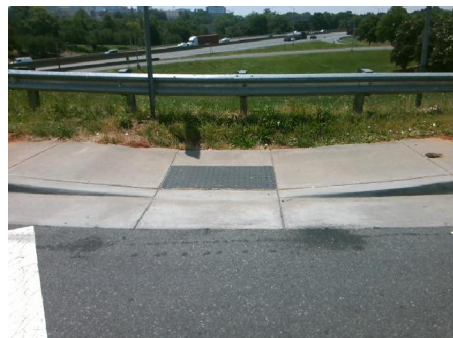
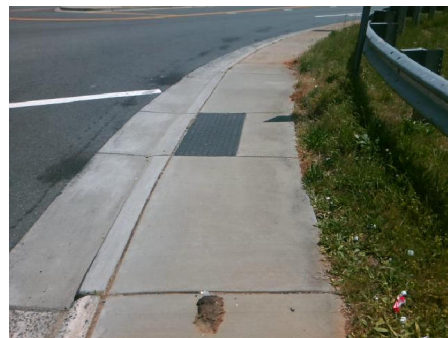
Street 1 Name W 5TH ST
 Stop Condition-Street 1 None
 Street 2 Name S I-77 EXIT 10B RA
 Stop Condition-Street 2 StopSign
