# Access Compliance Report

## Public Rights-of-Way

### (Curb Ramps)

Intersection ID: 10527	Main Street: PARKWAY_AV	Cross Street: TUCKASEEGEE_RD	Location: NW
ADA ID: ED2D320FBDFB	Ramp Type: PerpDiag	Initial Pass/Fail: Fail	Overall Compliance: No
			Severity Score: 26.25

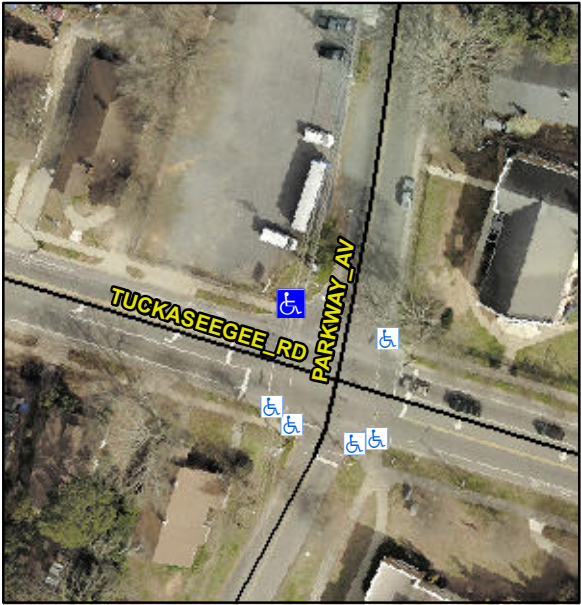
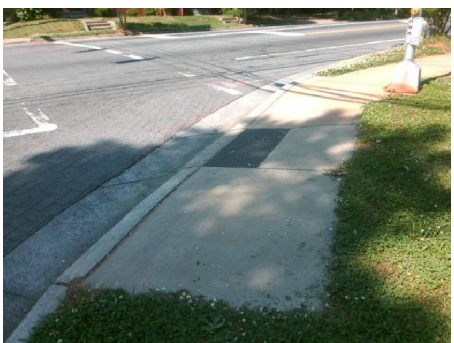
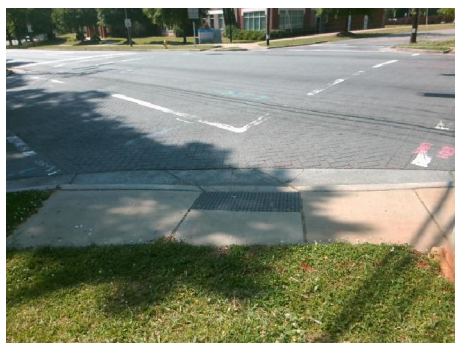
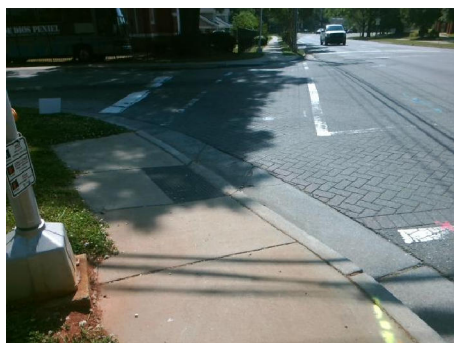
Possible Solutions:		<b>Compliance</b>	<b>Description</b>	<b>Data</b>
	<b>Remove &amp; Replace Curb Ramp With Two New Directional Ramps or Equivalent.</b>		<b>No</b>	Ramp Length (in)	<b>59.0</b>
			<b>Yes</b>	Ramp Width (in)	<b>48.0</b>
			<b>N/A</b>	Flare Type LT	<b>N/A</b>
			<b>N/A</b>	Flare Slope LT (%)	<b>N/A</b>
			<b>N/A</b>	Flare Traversable LT?	<b>N/A</b>
			<b>N/A</b>	Landing Length (in)	<b>N/A</b>
			<b>N/A</b>	Landing Width (in)	<b>N/A</b>
			<b>N/A</b>	Landing Slope (%)	<b>N/A</b>
			<b>N/A</b>	Landing X Slope (%)	<b>N/A</b>
<p>Surveyor Notes:</p> <p><b>N/A</b></p> <p>PROW/ADA:</p> <p><b>Not Found, R304.2.2, R304.5.3</b></p>			<b>N/A</b>	Flare Type RT	<b>N/A</b>
			<b>N/A</b>	Flare Slope RT (%)	<b>N/A</b>
			<b>N/A</b>	Flare Traversable RT?	<b>N/A</b>
			<b>N/A</b>	DWS Provided?	<b>N/A</b>
			<b>N/A</b>	DWS Contrast?	<b>N/A</b>

<b>N/A</b>	DWS Length (in)	<b>N/A</b>
			<b>N/A</b>	DWS Full Width?	<b>N/A</b>
			<b>N/A</b>	DWS Offset (in)	<b>N/A</b>
			<b>N/A</b>	Shared Landing?	<b>N/A</b>
			<b>N/A</b>	Gutter Ponding?	<b>N/A</b>
			<b>N/A</b>	Gutter Lip Ht (in)	<b>N/A</b>
			<b>N/A</b>	Painted X Walk1?	<b>Yes</b>
				X Walk 1 Direction	<b>To S</b>
			<b>N/A</b>	X Walk 1 Width (in)	<b>111.0</b>
				X Walk 1 Slope (%)	<b>9.0</b>
				X Walk 1 X Slope (%)	<b>1.9</b>
			<b>N/A</b>	Ramp inside XWalk1?	<b>Yes</b>
				Road Slope (%)	<b>2.9</b>
				Road X Slope (%)	<b>6.5</b>
			<b>N/A</b>	Any Obstructions?	<b>N/A</b>
				Obstruction Type	
Total Cost:
