Access Compliance Report

Public Rights-of-Way

(Curb Ramps)

Intersection ID: 26014	Main Street: ARRINGTON MANOR PL	Cross Street: HOLLY HILL FARM RD	Location: NE
ADA ID: ED3C8927CCDA	Ramp Type: PerpDiag	Initial Pass/Fail: Fail	Overall Compliance: No
Severity Score: 25			
Codes/Mitigation Info/Possible Solution		Field Measurements/Component Compliance

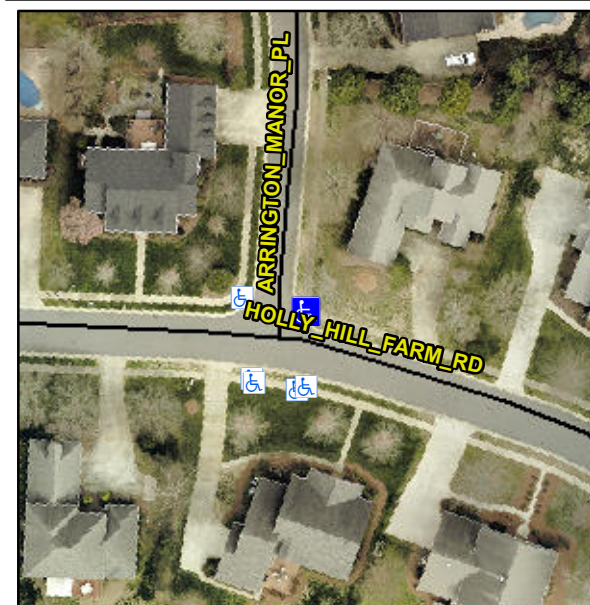
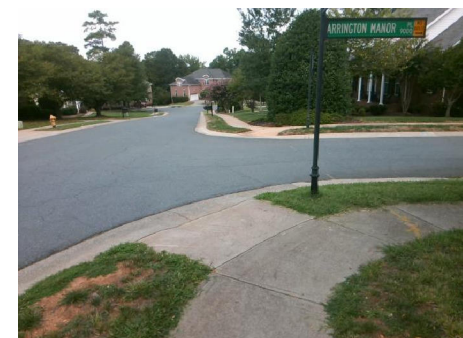
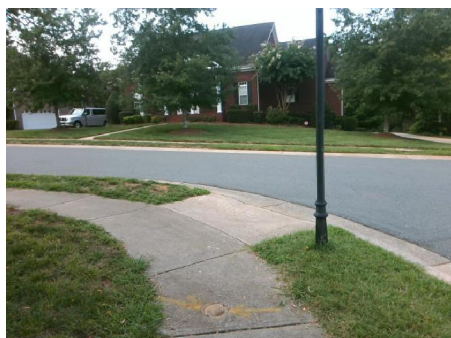
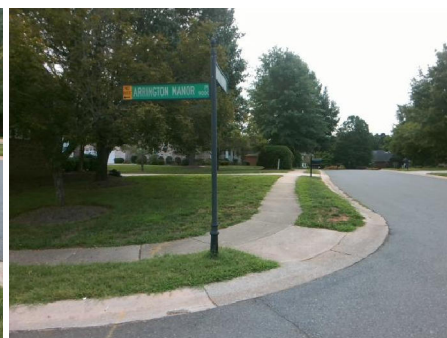
Compliance	Description	Data	Compliance	Description	Data
N/A	Ramp Length (in)	50.0	Yes	Ramp Slope (%)	7.1
Yes	Ramp Width (in)	48.0	No	Ramp XSlope (%)	7.0
N/A	Flare Type LT	N/A	N/A	Flare Type RT	N/A
N/A	Flare Slope LT (%)	N/A	N/A	Flare Slope RT (%)	N/A
N/A	Flare Traversable LT?	N/A	N/A	Flare Traversable RT?	N/A
N/A	Landing Length (in)	N/A	N/A	DWS Provided?	N/A
N/A	Landing Width (in)	N/A	N/A	DWS Contrast?	N/A
N/A	Landing Slope (%)	N/A	N/A	DWS Length (in)	N/A
N/A	Landing X Slope (%)	N/A	N/A	DWS Full Width?	N/A
N/A	Landing Curb? (Y/N)	N/A	N/A	DWS Offset (in)	N/A
N/A	Shared Landing?	N/A			
N/A	Gutter Ponding?	N/A	N/A	Gutter Slope (%)	N/A
N/A	Gutter Lip Ht (in)	N/A	N/A	Gutter X Slope (%)	N/A
N/A	Painted X Walk1?	No	N/A	Painted X Walk2?	No
	X Walk 1 Direction	To NW		X Walk 2 Direction	To SW
N/A	X Walk 1 Width (in)	N/A	N/A	X Walk 2 Width (in)	N/A
	X Walk 1 Slope (%)	5.2		X Walk 2 Slope (%)	4.9
	X Walk 1 X Slope (%)	4.0		X Walk 2 X Slope (%)	7.3

N/A	Ramp inside XWalk1?	N/A	N/A	Ramp inside XWalk2?	N/A
	Road Slope (%)	7.8	N/A	Clear Space?	N/A
	Road X Slope (%)	1.1	N/A	Clear Space to XWalk (in)	N/A
N/A	Any Obstructions?	N/A	N/A	Storm Grate/Utility Hazard?	N/A
	Obstruction Type			Storm Grate/Utility Type	
		N/A			N/A
		Yes		Surface Condition? (G/P)	Good

Possible Solutions:

Remove & Replace Curb Ramp With Two New Directional Ramps or Equivalent.
