Access Compliance Report

Public Rights-of-Way

(Curb Ramps)

Intersection ID: 48436	Main Street: BEDLINGTON_RD	Cross Street: ORANSAY_WY	Location: SW
ADA ID: ED4D257346A8	Ramp Type: Perp	Initial Pass/Fail: Pass	Overall Compliance: No
			Severity Score: 15.25

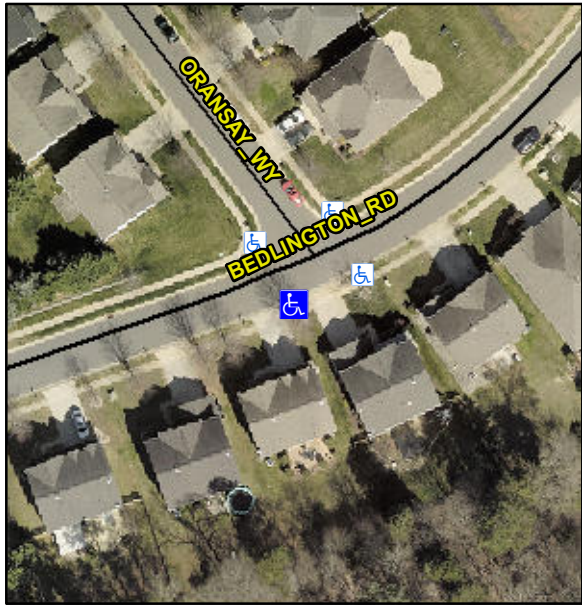
Possible Solutions:		Compliance		Description	Data	Compliance		Description	Data
	Install Landing. Remove & Replace Gutter.		N/A	Ramp Length (in)	93.5	Yes	Ramp Slope (%)	6.9		
			Yes	Ramp Width (in)	48.0	Yes	Ramp XSlope (%)	3.0		
			N/A	Flare Type LT	Sloped	N/A	Flare Type RT	N/A		
			N/A	Flare Slope LT (%)	8.7	Yes	Flare Slope RT (%)	2.0		
			N/A	Flare Traversable LT?	Yes	N/A	Flare Traversable RT?	Yes		
			No	Landing Length (in)	N/A	Yes	DWS Provided?	Yes		
			No	Landing Width (in)	N/A	Yes	DWS Contrast?	Yes		
			No	Landing Slope (%)	N/A	Yes	DWS Length (in)	24.0		
			No	Landing X Slope (%)	N/A	Yes	DWS Full Width?	Yes		
		N/A	Landing Curb? (Y/N)	No	Yes	DWS Offset (in)	1.0			
		N/A	Shared Landing?	No						
		Yes	Gutter Ponding?	No	No	Gutter Slope (%)	6.7			
		Yes	Gutter Lip Ht (in)	0.0	Yes	Gutter X Slope (%)	3.4			
		N/A	Painted X Walk1?	No	N/A	Painted X Walk2?	N/A

X Walk 1 Direction	To NW		X Walk 2 Direction	N/A			
		N/A	X Walk 1 Width (in)	N/A	N/A	X Walk 2 Width (in)	N/A			
			X Walk 1 Slope (%)	4.4		X Walk 2 Slope (%)	N/A			
			X Walk 1 X Slope (%)	4.0		X Walk 2 X Slope (%)	N/A			
		N/A	Ramp inside XWalk1?	N/A	N/A	Ramp inside XWalk2?	N/A			
			Road Slope (%)	N/A	N/A	Clear Space?	Yes			
			Road X Slope (%)	N/A	N/A	Clear Space to XWalk (in)	N/A			
		Yes	Any Obstructions?	No	Yes	Storm Grate/Utility Hazard?	No			
			Obstruction Type			Storm Grate/Utility Type				
				N/A			N/A			
					Yes	Surface Condition? (G/P)	Good
