Access Compliance Report

Public Rights-of-Way

(Curb Ramps)

Intersection ID: 28376	Main Street: GEORGIAN_HALL_DR	Cross Street: SOUTHAMPTON_COMMONS_DR	Location: SE
ADA ID: ED5280BD8FEB	Ramp Type: PerpDiag	Initial Pass/Fail: Fail	Overall Compliance: No
		Severity Score: 12.5

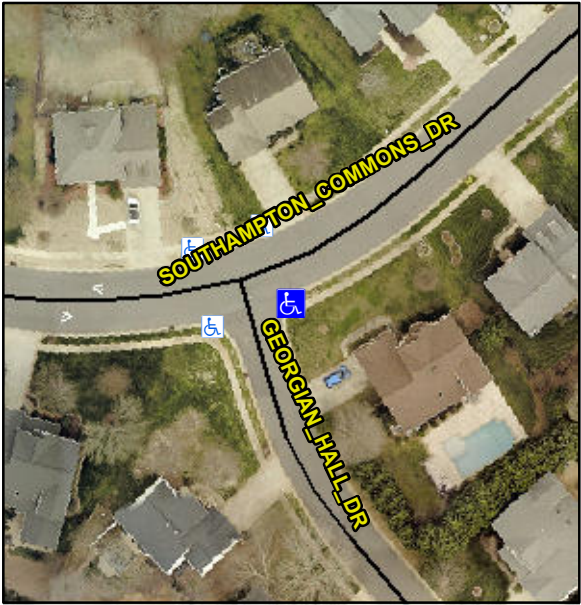
Compliance	Description	Data	Compliance	Description	Data
N/A	Ramp Length (in)	46.0	Yes	Ramp Slope (%)	7.6
Yes	Ramp Width (in)	60.0	No	Ramp XSlope (%)	5.7
N/A	Flare Type LT	N/A	N/A	Flare Type RT	N/A
N/A	Flare Slope LT (%)	N/A	N/A	Flare Slope RT (%)	N/A
N/A	Flare Traversable LT?	N/A	N/A	Flare Traversable RT?	N/A
N/A	Landing Length (in)	N/A	N/A	DWS Provided?	N/A
N/A	Landing Width (in)	N/A	N/A	DWS Contrast?	N/A
N/A	Landing Slope (%)	N/A	N/A	DWS Length (in)	N/A
N/A	Landing X Slope (%)	N/A	N/A	DWS Full Width?	N/A
N/A	Landing Curb? (Y/N)	N/A	N/A	DWS Offset (in)	N/A
N/A	Shared Landing?	N/A			
N/A	Gutter Ponding?	N/A	N/A	Gutter Slope (%)	N/A
N/A	Gutter Lip Ht (in)	N/A	N/A	Gutter X Slope (%)	N/A
N/A	Painted X Walk1?	No	N/A	Painted X Walk2?	No
	X Walk 1 Direction	To N		X Walk 2 Direction	To W
N/A	X Walk 1 Width (in)	N/A	N/A	X Walk 2 Width (in)	N/A
	X Walk 1 Slope (%)	1.8		X Walk 2 Slope (%)	5.9
	X Walk 1 X Slope (%)	5.5		X Walk 2 X Slope (%)	0.0

N/A	Ramp inside XWalk1?	N/A	N/A	Ramp inside XWalk2?	N/A
	Road Slope (%)	3.3	N/A	Clear Space?	N/A
	Road X Slope (%)	3.0	N/A	Clear Space to XWalk (in)	N/A
N/A	Any Obstructions?	N/A	N/A	Storm Grate/Utility Hazard?	N/A
	Obstruction Type			Storm Grate/Utility Type	
		N/A			N/A
			Yes	Surface Condition? (G/P)	Good

Possible Solutions:				
	Remove & Replace Curb Ramp With Two New Directional Ramps or Equivalent.				
	Surveyor Notes:				
	N/A				
	PROW/ADA:				
	R304.5.3				
Street 1 Name	SOUTHAMPTON COMMONS DR				
Stop Condition-Street 2	None				
Street 2 Name	GEORGIAN HALL DR				
Stop Condition-Street 1	StopSign				
Total Cost:		\$	3200.00
