# Access Compliance Report

## Public Rights-of-Way

### (Curb Ramps)

| Intersection ID: 14763 | Main Street: HERMITAGE_RD | Cross Street: QUEENS_RD | Location: SW |

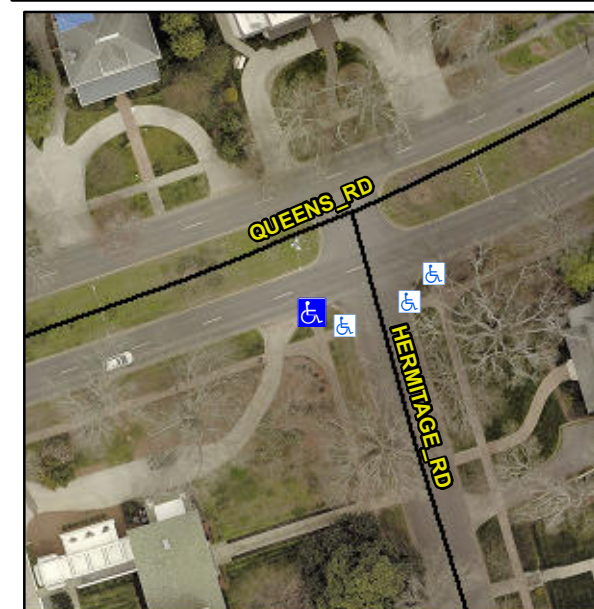
**R304.5.3, R304.2.1, R304.2.2-Perp,  
R304.3.2-Para, R305.1.4, R305.2**

| Compliance | Description | Data | Compliance | Description | Data |
|---|---|---|---|---|---|
| Yes | Ramp Slope (%) | 7.7 | No | Grade Break XSlope (%) | 2.3 |
| No | Ramp XSlope (%) | 2.6 | | | |
| No | Landing Length (in) | 47.0 | Yes | DWS Provided? | Yes |
| No | Landing Slope (%) | 4.8 | Yes | DWS Length (in) | 25.5 |
| Yes | Landing X Slope (%) | 0.5 | No | DWS Full Width? | No |
| N/A | Shared Landing? | No | No | DWS Offset RT (in) | 5.0 |
| Yes | Gutter Lip Ht (in) | 0.0 | No | Gutter X Slope (%) | 2.2 |

**Remove & Replace Entire Ramp.  
Remove & Replace Gutter.**
