Intersection ID: 24606	Main Street: CARTNESS_PL	Cross Street: MARYHURST_LN	Location:	SW
ADA ID: ED618E14665E	Ramp Type: PerpDiag	Initial Pass/Fail: Fail	Overall Compliance: No	Severity Score: 13.75

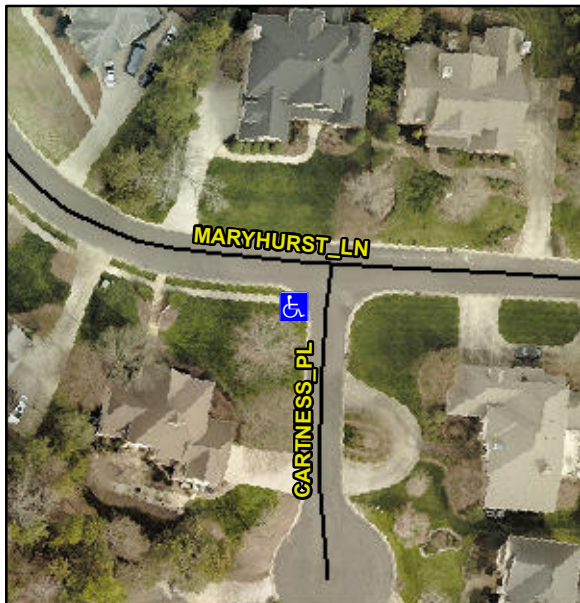
Possible Solutions:			Compliance	Description	Data	Compliance	Description	Data
	Remove & Replace Curb Ramp With Two New Directional Ramps or Equivalent.			N/A	Ramp Length (in)	97.0	No	Ramp Slope (%)	8.6
				Yes	Ramp Width (in)	48.0	No	Ramp XSlope (%)	3.8
				N/A	Flare Type LT	N/A	N/A	Flare Type RT	N/A
				N/A	Flare Slope LT (%)	N/A	N/A	Flare Slope RT (%)	N/A
				N/A	Flare Traversable LT?	N/A	N/A	Flare Traversable RT?	N/A
				N/A	Landing Length (in)	N/A	N/A	DWS Provided?	N/A
				N/A	Landing Width (in)	N/A	N/A	DWS Contrast?	N/A
				N/A	Landing Slope (%)	N/A	N/A	DWS Length (in)	N/A
				N/A	Landing X Slope (%)	N/A	N/A	DWS Full Width?	N/A
Surveyor Notes:			N/A	N/A	Landing Curb? (Y/N)	N/A	N/A	DWS Offset (in)	N/A
PROW/ADA:			R304.2.2, R304.5.3	N/A	Shared Landing?	N/A			
				N/A	Gutter Ponding?	N/A	N/A	Gutter Slope (%)	N/A

N/A	Gutter Lip Ht (in)	N/A	N/A	Gutter X Slope (%)	N/A
				N/A	Painted X Walk1?	No	N/A	Painted X Walk2?	No
					X Walk 1 Direction	To E		X Walk 2 Direction	To N
				N/A	X Walk 1 Width (in)	N/A	N/A	X Walk 2 Width (in)	N/A
					X Walk 1 Slope (%)	1.1		X Walk 2 Slope (%)	0.3
					X Walk 1 X Slope (%)	3.1		X Walk 2 X Slope (%)	0.6
Street 1 Name			CARTNESS PL	N/A	Ramp inside XWalk1?	N/A	N/A	Ramp inside XWalk2?	N/A
Stop Condition-Street 2			StopSign		Road Slope (%)	2.9	N/A	Clear Space?	N/A
Street 2 Name			MAYHURST LN		Road X Slope (%)	0.8	N/A	Clear Space to XWalk (in)	N/A
Stop Condition-Street 1			None	N/A	Any Obstructions?	N/A	N/A	Storm Grate/Utility Hazard?	N/A
					Obstruction Type			Storm Grate/Utility Type	
						N/A			N/A
							Yes	Surface Condition? (G/P)	Good
Total Cost:			\$ 3200.00
