Access Compliance Report

Public Rights-of-Way

(Curb Ramps)

Intersection ID: 3761	Main Street: KEENELAND_LN	Cross Street: CLAIBORNE_WOODS_RD	Location: NW
ADA ID: ED7D43468586	Ramp Type: Perp	Initial Pass/Fail: Fail	Overall Compliance: No
Severity Score: 8.75			
Codes/Mitigation Info/Possible Solution		Field Measurements/Component Compliance

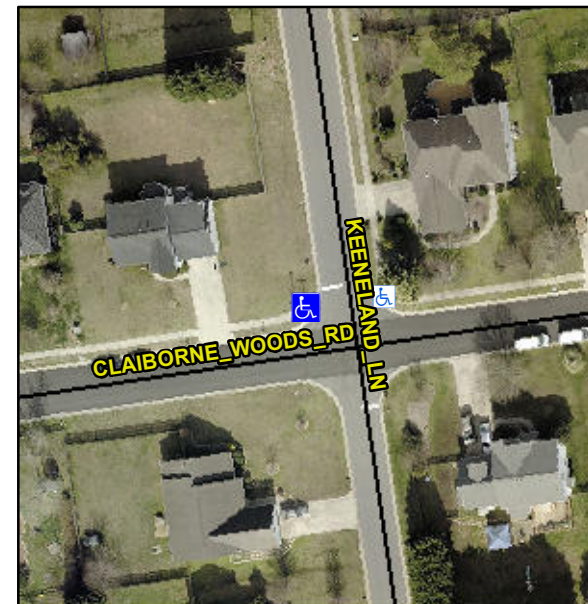
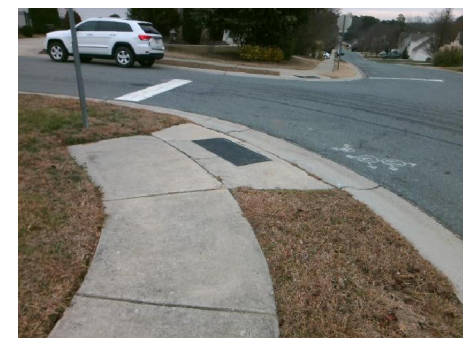
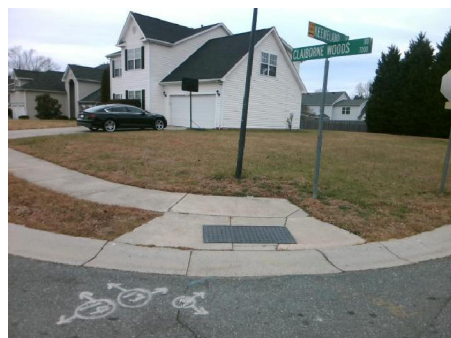
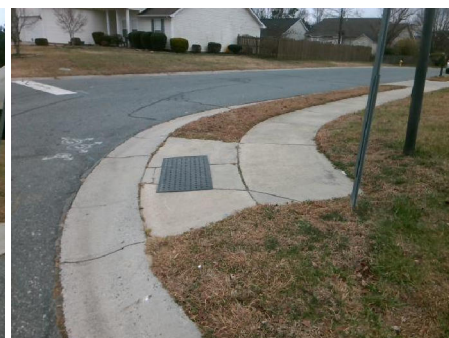
Not Found, R304.5.1

Compliance	Description	Data	Compliance	Description	Data
N/A	Ramp Length (in)	48.0	Yes	Ramp Slope (%)	7.9
No	Ramp Width (in)	42.0	Yes	Ramp XSlope (%)	0.4
N/A	Flare Type LT	N/A	N/A	Flare Type RT	N/A
N/A	Flare Slope LT (%)	N/A	N/A	Flare Slope RT (%)	N/A
N/A	Flare Traversable LT?	N/A	N/A	Flare Traversable RT?	N/A
N/A	Landing Length (in)	N/A	N/A	DWS Provided?	N/A
N/A	Landing Width (in)	N/A	N/A	DWS Contrast?	N/A
N/A	Landing Slope (%)	N/A	N/A	DWS Length (in)	N/A
N/A	Landing X Slope (%)	N/A	N/A	DWS Full Width?	N/A
N/A	Landing Curb? (Y/N)	N/A	N/A	DWS Offset (in)	N/A
N/A	Shared Landing?	N/A			
N/A	Gutter Ponding?	N/A	N/A	Gutter Slope (%)	N/A
N/A	Gutter Lip Ht (in)	N/A	N/A	Gutter X Slope (%)	N/A
N/A	Painted X Walk1?	No	N/A	Painted X Walk2?	N/A
	X Walk 1 Direction	To E		X Walk 2 Direction	N/A
N/A	X Walk 1 Width (in)	N/A	N/A	X Walk 2 Width (in)	N/A
	X Walk 1 Slope (%)	0.1		X Walk 2 Slope (%)	N/A
	X Walk 1 X Slope (%)	0.7		X Walk 2 X Slope (%)	N/A

N/A	Ramp inside XWalk1?	N/A	N/A	Ramp inside XWalk2?	N/A
	Road Slope (%)	N/A	N/A	Clear Space?	N/A
	Road X Slope (%)	N/A	N/A	Clear Space to XWalk (in)	N/A
N/A	Any Obstructions?	N/A	N/A	Storm Grate/Utility Hazard?	N/A
	Obstruction Type			Storm Grate/Utility Type	
		N/A			N/A
			Yes	Surface Condition? (G/P)	Good

Possible Solutions:

Remove & Replace Entire Ramp.

Total Cost: \$ 1850.00
