Access Compliance Report

Public Rights-of-Way

(Curb Ramps)

Intersection ID: N/A	Main Street: ROCK_ISLAND_RD	Cross Street: AGNEW_DR	Location: E
ADA ID: ED8A5751E1D5	Ramp Type: Perp	Initial Pass/Fail: Fail	Overall Compliance: No
Severity Score: 33.75			
Codes/Mitigation Info/Possible Solution		Field Measurements/Component Compliance

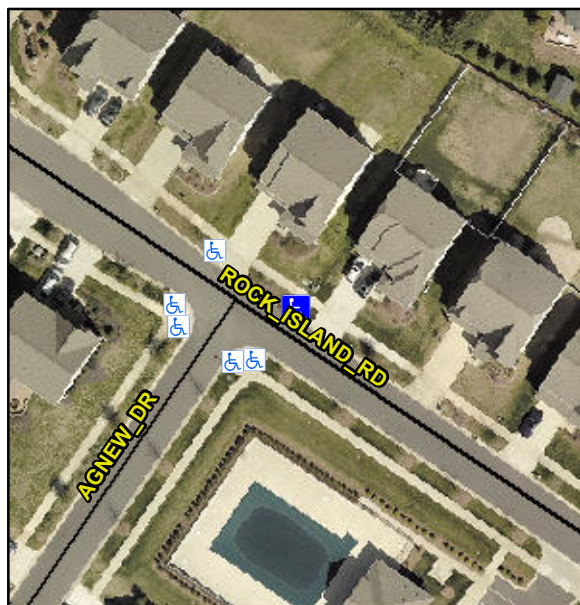
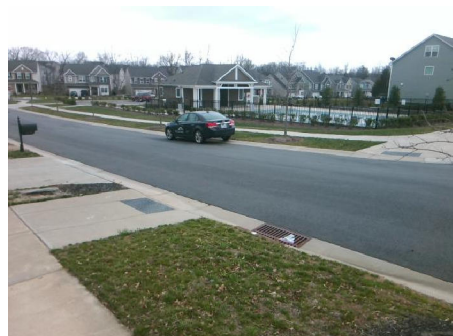
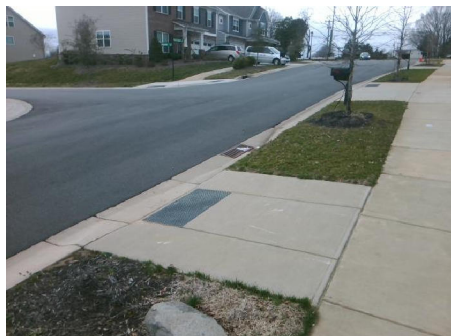
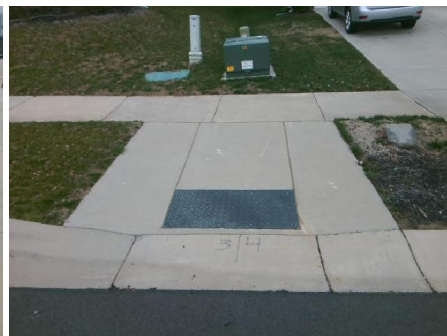
Not Found, R304.5.1, R304.2.2, R304.5.3

Compliance	Description	Data	Compliance	Description	Data
N/A	Ramp Length (in)	96.0	No	Ramp Slope (%)	8.5
No	Ramp Width (in)	46.5	No	Ramp XSlope (%)	6.6
N/A	Flare Type LT	N/A	N/A	Flare Type RT	N/A
N/A	Flare Slope LT (%)	N/A	N/A	Flare Slope RT (%)	N/A
N/A	Flare Traversable LT?	N/A	N/A	Flare Traversable RT?	N/A
N/A	Landing Length (in)	N/A	N/A	DWS Provided?	N/A
N/A	Landing Width (in)	N/A	N/A	DWS Contrast?	N/A
N/A	Landing Slope (%)	N/A	N/A	DWS Length (in)	N/A
N/A	Landing X Slope (%)	N/A	N/A	DWS Full Width?	N/A
N/A	Landing Curb? (Y/N)	N/A	N/A	DWS Offset (in)	N/A
N/A	Shared Landing?	N/A			
N/A	Gutter Ponding?	N/A	N/A	Gutter Slope (%)	N/A
N/A	Gutter Lip Ht (in)	N/A	N/A	Gutter X Slope (%)	N/A
N/A	Painted X Walk1?	No	N/A	Painted X Walk2?	N/A
	X Walk 1 Direction	To SW		X Walk 2 Direction	N/A
N/A	X Walk 1 Width (in)	N/A	N/A	X Walk 2 Width (in)	N/A
	X Walk 1 Slope (%)	5.5		X Walk 2 Slope (%)	N/A
	X Walk 1 X Slope (%)	6.3		X Walk 2 X Slope (%)	N/A

N/A	Ramp inside XWalk1?	N/A	N/A	Ramp inside XWalk2?	N/A
	Road Slope (%)	N/A	N/A	Clear Space?	N/A
	Road X Slope (%)	N/A	N/A	Clear Space to XWalk (in)	N/A
N/A	Any Obstructions?	N/A	N/A	Storm Grate/Utility Hazard?	N/A
	Obstruction Type			Storm Grate/Utility Type	
		N/A			N/A
			Yes	Surface Condition? (G/P)	Good

Remove & Replace Entire Ramp.
