# Access Compliance Report

## Public Rights-of-Way

### (Curb Ramps)

Intersection ID: N/A	Main Street: COSTIGAN_LN	Cross Street: BALLANTYNE_VILLAGE_WY	Location: NW
ADA ID: ED926B392A94	Ramp Type: PerpDiag	Initial Pass/Fail: Fail	Overall Compliance: No
Codes/Mitigation Info/Possible Solution		Field Measurements/Component Compliance	
Severity Score: 17.5

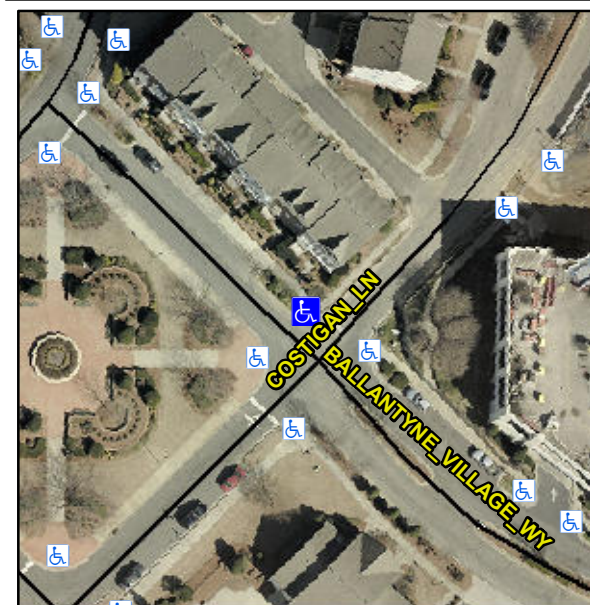
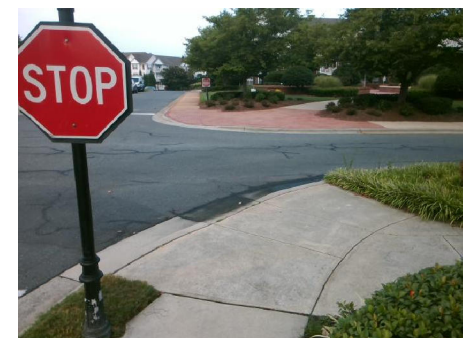
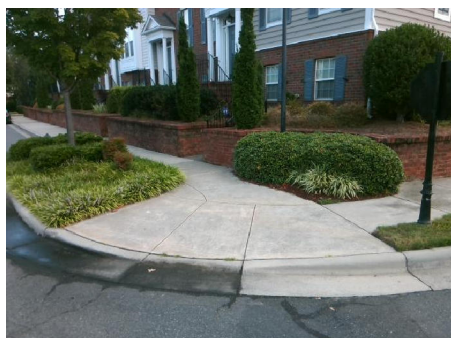
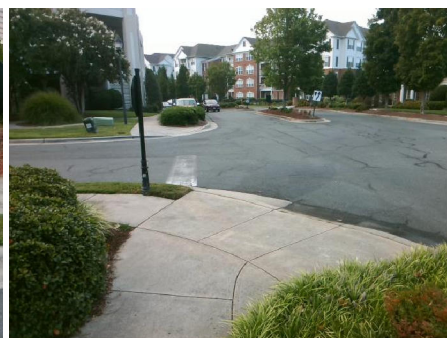
Compliance	Description	Data	Compliance	Description	Data
N/A	Ramp Length (in)	71.5	Yes	Ramp Slope (%)	7.6
No	Ramp Width (in)	33.0	Yes	Ramp XSlope (%)	1.1
N/A	Flare Type LT	N/A	N/A	Flare Type RT	N/A
N/A	Flare Slope LT (%)	N/A	N/A	Flare Slope RT (%)	N/A
N/A	Flare Traversable LT?	N/A	N/A	Flare Traversable RT?	N/A
N/A	Landing Length (in)	N/A	N/A	DWS Provided?	N/A
N/A	Landing Width (in)	N/A	N/A	DWS Contrast?	N/A
N/A	Landing Slope (%)	N/A	N/A	DWS Length (in)	N/A
N/A	Landing X Slope (%)	N/A	N/A	DWS Full Width?	N/A
N/A	Landing Curb? (Y/N)	N/A	N/A	DWS Offset (in)	N/A
N/A	Shared Landing?	N/A			
N/A	Gutter Ponding?	N/A	N/A	Gutter Slope (%)	N/A
N/A	Gutter Lip Ht (in)	N/A	N/A	Gutter X Slope (%)	N/A
N/A	Painted X Walk1?	No	N/A	Painted X Walk2?	No
	X Walk 1 Direction	To SW		X Walk 2 Direction	To SE
N/A	X Walk 1 Width (in)	N/A	N/A	X Walk 2 Width (in)	N/A
	X Walk 1 Slope (%)	2.3		X Walk 2 Slope (%)	1.7
	X Walk 1 X Slope (%)	0.4		X Walk 2 X Slope (%)	0.3

N/A	Ramp inside XWalk1?	N/A	N/A	Ramp inside XWalk2?	N/A
	Road Slope (%)	0.3	N/A	Clear Space?	N/A
	Road X Slope (%)	1.3	N/A	Clear Space to XWalk (in)	N/A
N/A	Any Obstructions?	N/A	N/A	Storm Grate/Utility Hazard?	N/A
	Obstruction Type			Storm Grate/Utility Type	
		N/A			N/A
			Yes	Surface Condition? (G/P)	Good

**Remove & Replace Curb Ramp With Two New Directional Ramps or Equivalent.**

**Not Found, R304.5.1**
