# Access Compliance Report

## Public Rights-of-Way

### (Curb Ramps)

Intersection ID: 53925	Main Street: RORY_GLEN_LN	Cross Street: PINYON_PINE_LN	Location: SW
ADA ID: ED9369C7A509	Ramp Type: BlendTrans1	Initial Pass/Fail: Fail	Overall Compliance: No
			Severity Score: 18.75

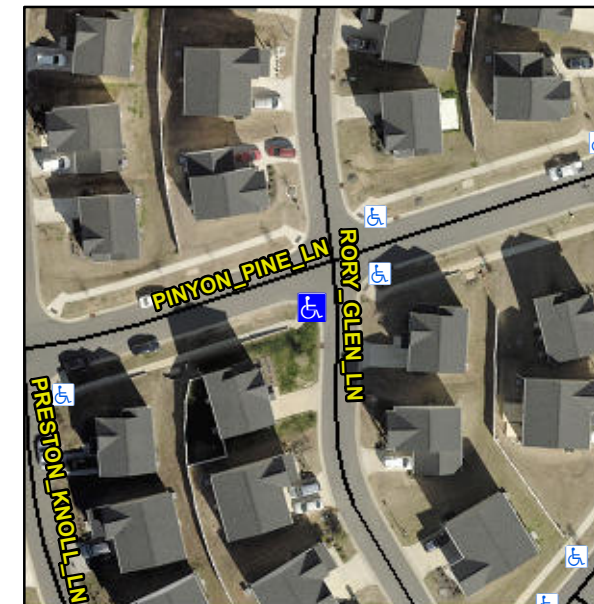
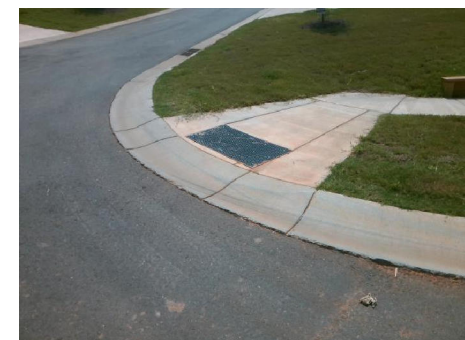
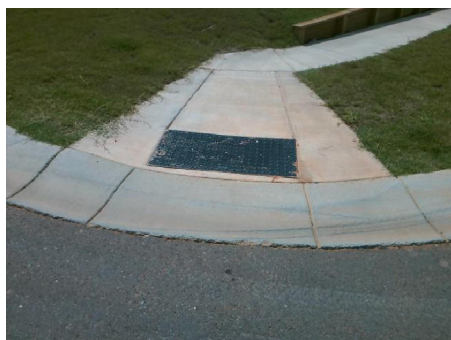
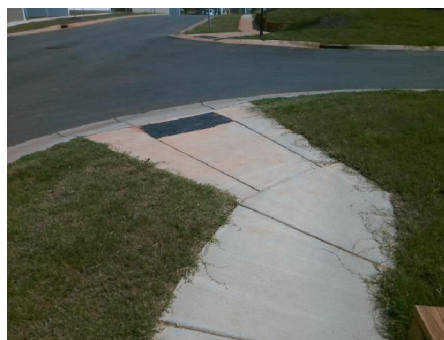
**NO LT SW**

**Not Found, R304.5.1, R304.5.3**

Compliance	Description	Data	Compliance	Description	Data
N/A	Ramp Length (in)	98.5	Yes	BlendTrans Slope (%)	0.4
No	Ramp Width (in)	32.5	No	BlendTrans XSlope (%)	4.0
N/A	Flare Type LT	N/A	N/A	Flare Type RT	N/A
N/A	Flare Slope LT (%)	N/A	N/A	Flare Slope RT (%)	N/A
N/A	Flare Traversable LT?	N/A	N/A	Flare Traversable RT?	N/A
N/A	Landing Length (in)	N/A	N/A	DWS Provided?	N/A
N/A	Landing Width (in)	N/A	N/A	DWS Contrast?	N/A
N/A	Landing Slope (%)	N/A	N/A	DWS Length (in)	N/A
N/A	Landing X Slope (%)	N/A	N/A	DWS Full Width?	N/A
N/A	Landing Curb? (Y/N)	N/A	N/A	DWS Offset (in)	N/A
N/A	Shared Landing?	N/A			
N/A	Gutter Ponding?	N/A	N/A	Gutter Slope (%)	N/A
N/A	Gutter Lip Ht (in)	N/A	N/A	Gutter X Slope (%)	N/A
N/A	Painted X Walk1?	No	N/A	Painted X Walk2?	No
	X Walk 1 Direction	To E		X Walk 2 Direction	To N
	X Walk 1 Width (in)	N/A		X Walk 2 Width (in)	N/A
	X Walk 1 Slope (%)	7.2		X Walk 2 Slope (%)	1.9
	X Walk 1 X Slope (%)	3.9		X Walk 2 X Slope (%)	5.6

N/A	Ramp inside XWalk1?	N/A	N/A	Ramp inside XWalk2?	N/A
	Road Slope (%)	6.3		Clear Space?	N/A
	Road X Slope (%)	4.5	N/A	Clear Space to XWalk (in)	N/A
N/A	Any Obstructions?	N/A	N/A	Storm Grate/Utility Hazard?	N/A
	Obstruction Type			Storm Grate/Utility Type	
		N/A			N/A
			Yes	Surface Condition? (G/P)	Good
			No	Curb Slope (%)	12.1

**Remove & Replace Curb Ramp With Two New Directional Ramps or Equivalent.**
