Intersection ID: 3106	Main Street: DAUPHINE_DR	Cross Street: SANDMAN_LN	Location:	N/A
ADA ID: ED948F66CABB	Ramp Type: Perp	Initial Pass/Fail: Fail	Overall Compliance: No	Severity Score: 50

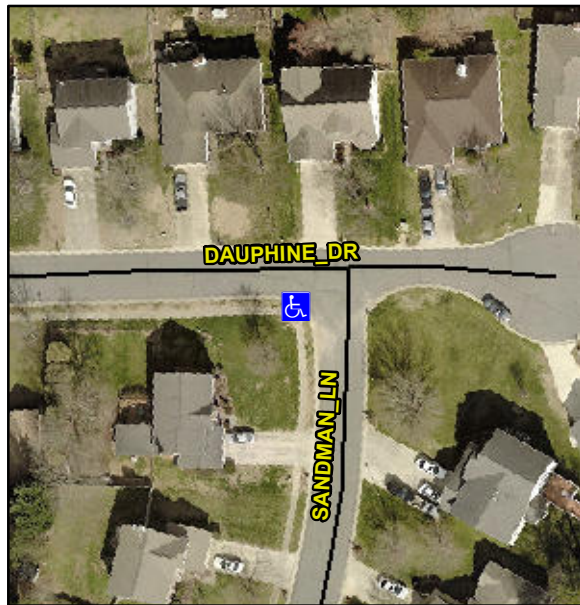
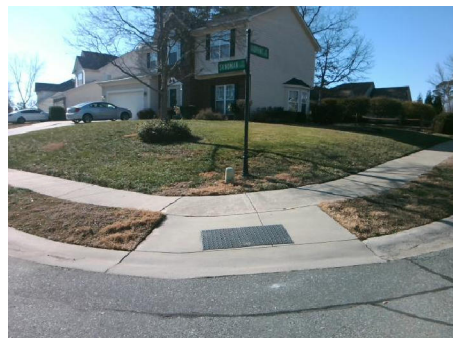
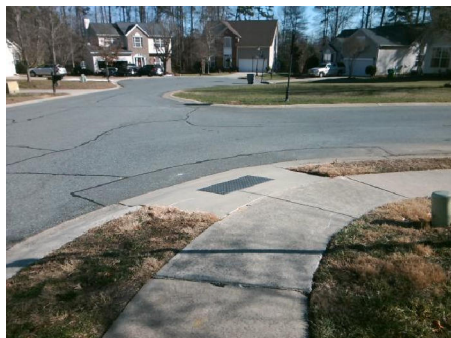
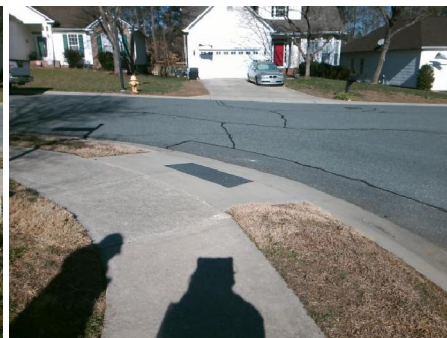
Not Found, R304.2.2, R304.5.3

Possible Solutions:			Compliance	Description	Data	Compliance	Description	Data
Remove & Replace Entire Ramp.	N/A	Ramp Length (in)	46.5	No	Ramp Slope (%)	15.6		
	Yes	Ramp Width (in)	48.0	No	Ramp XSlope (%)	7.9		
	N/A	Flare Type LT	N/A	N/A	Flare Type RT	N/A		
	N/A	Flare Slope LT (%)	N/A	N/A	Flare Slope RT (%)	N/A		
	N/A	Flare Traversable LT?	N/A	N/A	Flare Traversable RT?	N/A		
	N/A	Landing Length (in)	N/A	N/A	DWS Provided?	N/A		
	N/A	Landing Width (in)	N/A	N/A	DWS Contrast?	N/A		
	N/A	Landing Slope (%)	N/A	N/A	DWS Length (in)	N/A		
	N/A	Landing X Slope (%)	N/A	N/A	DWS Full Width?	N/A		
	N/A	Landing Curb? (Y/N)	N/A	N/A	DWS Offset (in)	N/A		
Surveyor Notes: N/A	N/A	Shared Landing?	N/A					
	N/A	Gutter Ponding?	N/A	N/A	Gutter Slope (%)	N/A		
	N/A	Gutter Lip Ht (in)	N/A	N/A	Gutter X Slope (%)	N/A		
	N/A	Painted X Walk1?	No	N/A	Painted X Walk2?	N/A		
		X Walk 1 Direction	To E		X Walk 2 Direction	N/A		
	N/A	X Walk 1 Width (in)	N/A	N/A	X Walk 2 Width (in)	N/A

X Walk 1 Slope (%)	5.4		X Walk 2 Slope (%)	N/A		
		X Walk 1 X Slope (%)	1.8		X Walk 2 X Slope (%)	N/A		
	N/A	Ramp inside XWalk1?	N/A	N/A	Ramp inside XWalk2?	N/A		
		Road Slope (%)	1.8	N/A	Clear Space?	N/A		
PROW/ADA: Not Found, R304.2.2, R304.5.3		Road X Slope (%)	5.4	N/A	Clear Space to XWalk (in)	N/A		
	N/A	Any Obstructions?	N/A	N/A	Storm Grate/Utility Hazard?	N/A		
		Obstruction Type			Storm Grate/Utility Type			
			N/A			N/A		
				Yes	Surface Condition? (G/P)	Good		
Total Cost:	\$	1850.00

Remove & Replace Entire Ramp.
