## Access Compliance Report Public Rights-of-Way (Curb Ramps)

Intersection ID: 26318	26318 Main Street: BEAUCATCHER_LN			Cross Street: INDIA_WILKES_PL					Location:	NW
ADA ID: ED95E9345136	A ID: ED95E9345136 Ramp Type: Perp				Initial Pass/Fail: Fail Overall Compliance: No					33.75
Codes/Mitigation Info/Possible Solution			Field Measurements/Component Compliance							
	A State	Possible Solutions:	Compliance Description			Data Compliance Description			Data	
ALL TAK	S. A.	Remove & Replac	e Entire Ramp.	N/A	Ramp Len	gth (in)	93.0	Yes	Ramp Slope (%)	5.5
	BALL		•	No	Ramp Wid	th (in)	38.0	No	Ramp XSlope (%)	9.3

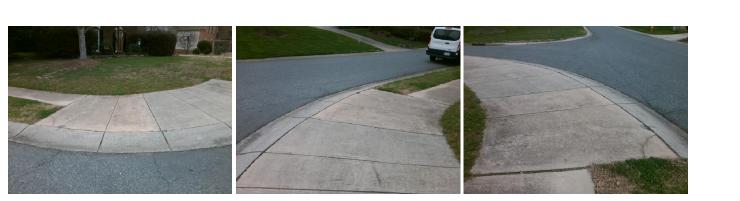
**Yes** Surface Condition? (G/P)

Good

S. MAN			N/A	Shared La	nding?	N/A			
A Distant	1 AL	PROW/ADA:		N/A	Gutter Por	nding?	N/A	N/A	Gutter Slope (%)	N/A
	12 8 1	Not Found, R304.	5.1. R304.5.3	N/A	Gutter Lip	Ht (in)	N/A	N/A	Gutter X Slope (%)	N/A
