# Access Compliance Report

## Public Rights-of-Way

| Intersection ID: 48494 | Main Street: MELFORT_WY | Cross Street: BEREWICK_COMMONS_PY | Location: SW |
| ADA ID: EDA8F1826838 | Ramp Type: PerpDiag | Initial Pass/Fail: Fail | Overall Compliance: No |

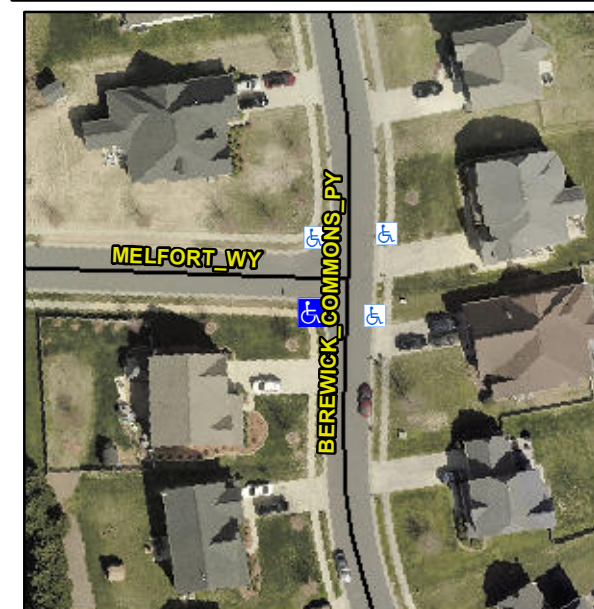
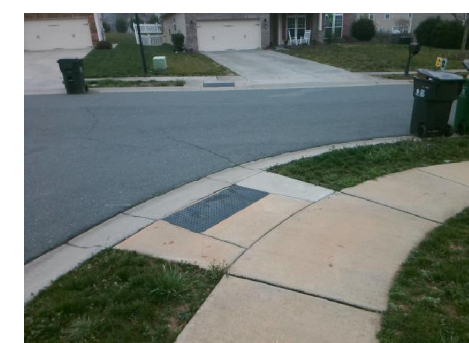
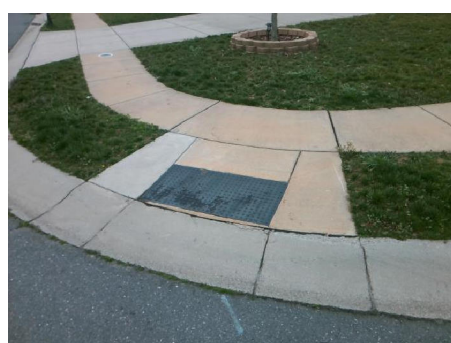
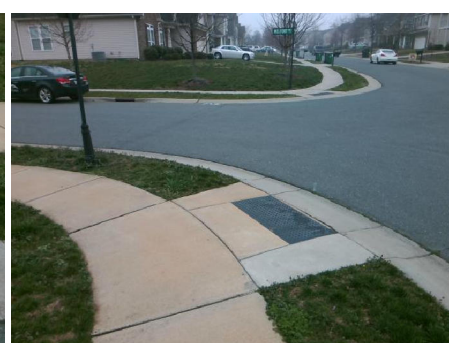
| Severity Score: 13.75 | | | |

**Not Found, R304.2.2, R304.5.3**

| Compliance | Description | Data | Compliance | Description | Data |
|---|---|---|---|---|---|
| N/A | Ramp Length (in) | 48.0 | No | Ramp Slope (%) | 9.4 |
| Yes | Ramp Width (in) | 48.0 | No | Ramp XSlope (%) | 2.3 |

**Remove & Replace Curb Ramp With Two New Directional Ramps or Equivalent.**

Total Cost: \$ 3200.00
