Intersection ID: 44822	Main Street: GOLDEN_RIDGE_LN	Cross Street: HIRAM_ST	Location:	NE
ADA ID: EDB8E4396A2F	Ramp Type: PerpDiag	Initial Pass/Fail: Fail	Overall Compliance: No	Severity Score: 33.75

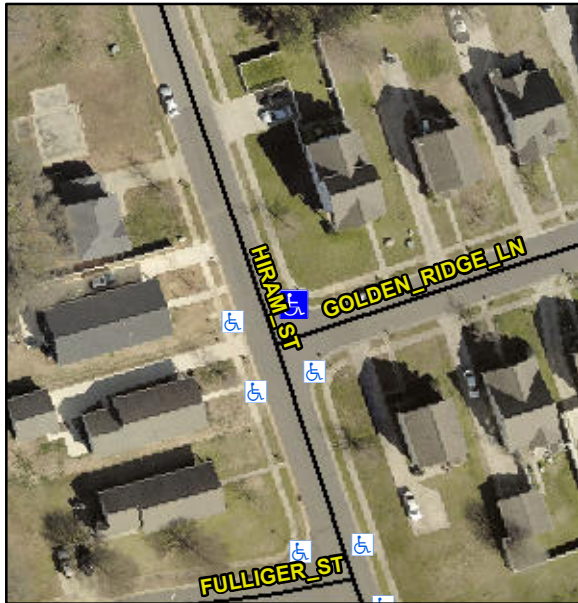
Not Found, R304.5.1, R304.5.3

Compliance	Description	Data	Compliance	Description	Data
N/A	Ramp Length (in)	94.0	Yes	Ramp Slope (%)	5.3
No	Ramp Width (in)	40.0	No	Ramp XSlope (%)	15.4
N/A	Flare Type LT	N/A	N/A	Flare Type RT	N/A
N/A	Flare Slope LT (%)	N/A	N/A	Flare Slope RT (%)	N/A
N/A	Flare Traversable LT?	N/A	N/A	Flare Traversable RT?	N/A
N/A	Landing Length (in)	N/A	N/A	DWS Provided?	N/A
N/A	Landing Width (in)	N/A	N/A	DWS Contrast?	N/A
N/A	Landing Slope (%)	N/A	N/A	DWS Length (in)	N/A
N/A	Landing X Slope (%)	N/A	N/A	DWS Full Width?	N/A
N/A	Landing Curb? (Y/N)	N/A	N/A	DWS Offset (in)	N/A
N/A	Shared Landing?	N/A			
N/A	Gutter Ponding?	N/A	N/A	Gutter Slope (%)	N/A
N/A	Gutter Lip Ht (in)	N/A	N/A	Gutter X Slope (%)	N/A
N/A	Painted X Walk1?	No	N/A	Painted X Walk2?	No
	X Walk 1 Direction	To W		X Walk 2 Direction	To S
N/A	X Walk 1 Width (in)	N/A	N/A	X Walk 2 Width (in)	N/A
	X Walk 1 Slope (%)	5.0		X Walk 2 Slope (%)	2.9
	X Walk 1 X Slope (%)	3.6		X Walk 2 X Slope (%)	7.6

N/A	Ramp inside XWalk1?	N/A	N/A	Ramp inside XWalk2?	N/A
	Road Slope (%)	9.5	N/A	Clear Space?	N/A
	Road X Slope (%)	1.7	N/A	Clear Space to XWalk (in)	N/A
N/A	Any Obstructions?	N/A	N/A	Storm Grate/Utility Hazard?	N/A
	Obstruction Type			Storm Grate/Utility Type	
		N/A			N/A
			Yes	Surface Condition? (G/P)	Good

Remove & Replace Curb Ramp With Two New Directional Ramps or Equivalent.
