Access Compliance Report

Public Rights-of-Way

(Curb Ramps)

| Intersection ID: N/A | Main Street: CRESSWIND BV | Cross Street: TREESDALE LN | Location: S |

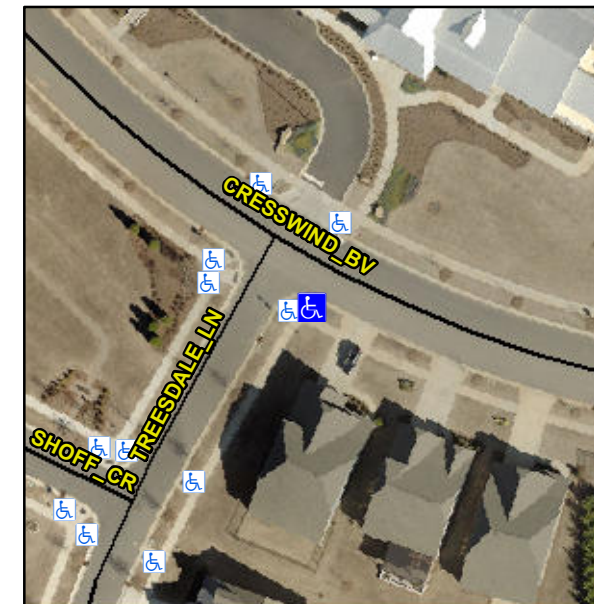
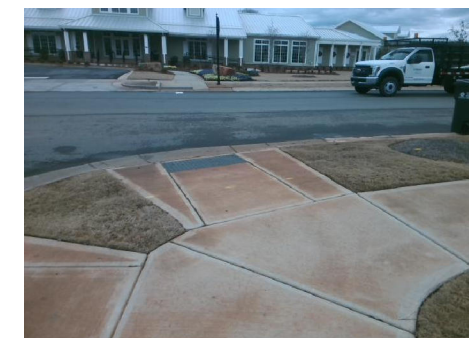
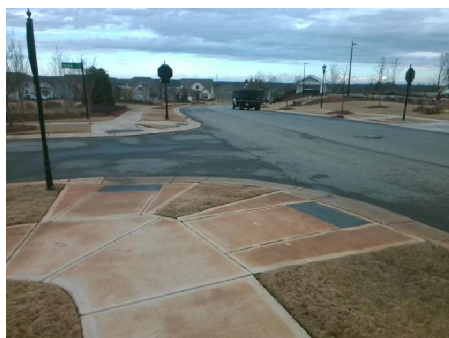
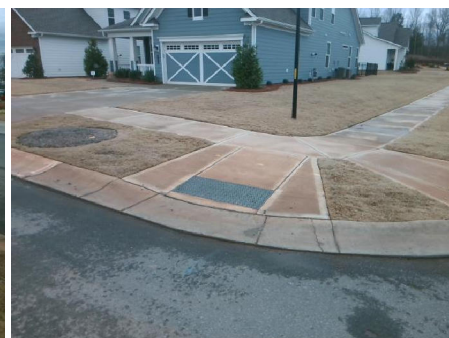
| ADA ID: EDC06FBCA2D6 | Ramp Type: Perp | Initial Pass/Fail: Fail | Overall Compliance: No |
| Severity Score: 1.25 | | | |

R304.5.3

| Compliance | Description | Data | Compliance | Description | Data |
|---|---|---|---|---|---|
| Yes | Ramp Width (in) | 48.0 | No | Ramp XSlope (%) | 3.5 |

Remove & Replace Entire Ramp.
