Access Compliance Report

Public Rights-of-Way

(Curb Ramps)

Intersection ID: 21061	Main Street: SARDIS_RD	Cross Street: SMITHFIELD_DR	Location: SE
ADA ID: EDC65CF69E59	Ramp Type: PerpDiag	Initial Pass/Fail: Fail	Overall Compliance: No
Severity Score: 22.5			
Codes/Mitigation Info/Possible Solution		Field Measurements/Component Compliance

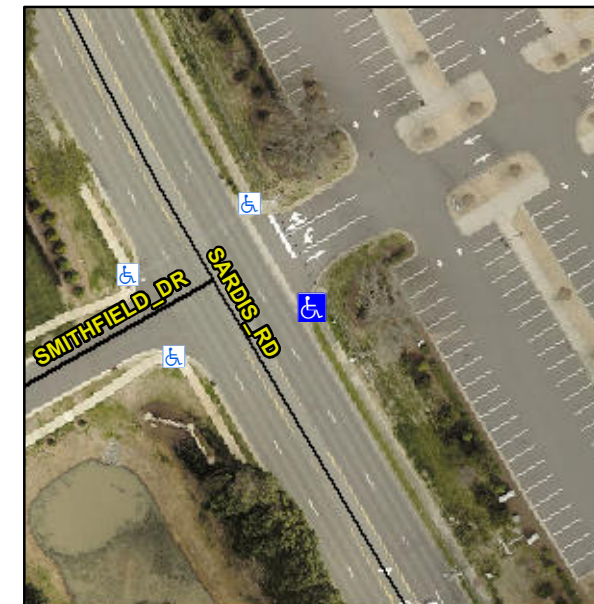
Not Found, R304.5.1, R304.2.2, R304.5.3

Compliance	Description	Data	Compliance	Description	Data
N/A	Ramp Length (in)	56.0	No	Ramp Slope (%)	8.6
No	Ramp Width (in)	46.0	No	Ramp XSlope (%)	2.9
N/A	Flare Type LT	N/A	N/A	Flare Type RT	N/A
N/A	Flare Slope LT (%)	N/A	N/A	Flare Slope RT (%)	N/A
N/A	Flare Traversable LT?	N/A	N/A	Flare Traversable RT?	N/A
N/A	Landing Length (in)	N/A	N/A	DWS Provided?	N/A
N/A	Landing Width (in)	N/A	N/A	DWS Contrast?	N/A
N/A	Landing Slope (%)	N/A	N/A	DWS Length (in)	N/A
N/A	Landing X Slope (%)	N/A	N/A	DWS Full Width?	N/A
N/A	Landing Curb? (Y/N)	N/A	N/A	DWS Offset (in)	N/A
N/A	Shared Landing?	N/A			
N/A	Gutter Ponding?	N/A	N/A	Gutter Slope (%)	N/A
N/A	Gutter Lip Ht (in)	N/A	N/A	Gutter X Slope (%)	N/A
N/A	Painted X Walk1?	No	N/A	Painted X Walk2?	No
	X Walk 1 Direction	To N		X Walk 2 Direction	To W
N/A	X Walk 1 Width (in)	N/A	N/A	X Walk 2 Width (in)	N/A
	X Walk 1 Slope (%)	0.2		X Walk 2 Slope (%)	4.8
	X Walk 1 X Slope (%)	1.6		X Walk 2 X Slope (%)	4.1

N/A	Ramp inside XWalk1?	N/A	N/A	Ramp inside XWalk2?	N/A
	Road Slope (%)	1.9	N/A	Clear Space?	N/A
	Road X Slope (%)	0.8	N/A	Clear Space to XWalk (in)	N/A
N/A	Any Obstructions?	N/A	N/A	Storm Grate/Utility Hazard?	N/A
	Obstruction Type			Storm Grate/Utility Type	
		N/A			N/A
		Yes		Surface Condition? (G/P)	Good

Possible Solutions:

Remove & Replace Curb Ramp With Two New Directional Ramps or Equivalent.
