# Access Compliance Report

## Public Rights-of-Way

### (Curb Ramps)

Intersection ID: 17505	Main Street: CRAIG_AV	Cross Street: N_SHARON_AMITY_RD	Location: NW
ADA ID: EDD08B1F4B1D	Ramp Type: PerpDiag	Initial Pass/Fail: Fail	Overall Compliance: No
Severity Score: 22.5			
Codes/Mitigation Info/Possible Solution		Field Measurements/Component Compliance

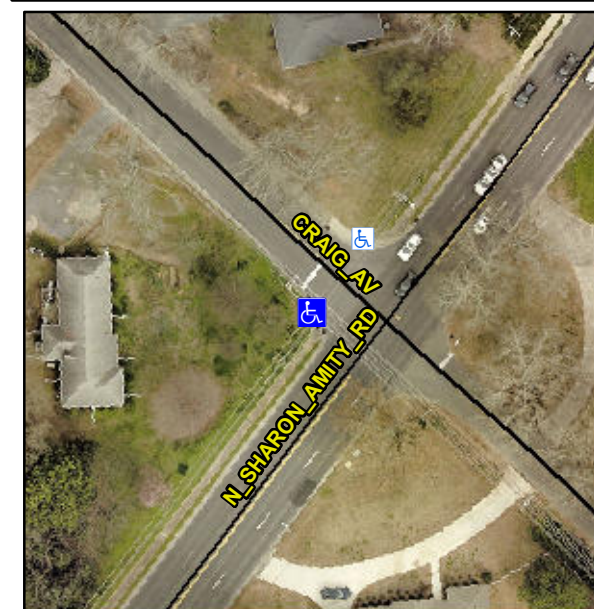
**Not Found, R304.5.1, R304.2.2, R304.5.3**

Compliance	Description	Data	Compliance	Description	Data
N/A	Ramp Length (in)	60.0	No	Ramp Slope (%)	9.9
No	Ramp Width (in)	38.0	No	Ramp XSlope (%)	4.0
N/A	Flare Type LT	N/A	N/A	Flare Type RT	N/A
N/A	Flare Slope LT (%)	N/A	N/A	Flare Slope RT (%)	N/A
N/A	Flare Traversable LT?	N/A	N/A	Flare Traversable RT?	N/A
N/A	Landing Length (in)	N/A	N/A	DWS Provided?	N/A
N/A	Landing Width (in)	N/A	N/A	DWS Contrast?	N/A
N/A	Landing Slope (%)	N/A	N/A	DWS Length (in)	N/A
N/A	Landing X Slope (%)	N/A	N/A	DWS Full Width?	N/A
N/A	Landing Curb? (Y/N)	N/A	N/A	DWS Offset (in)	N/A
N/A	Shared Landing?	N/A			
N/A	Gutter Ponding?	N/A	N/A	Gutter Slope (%)	N/A
N/A	Gutter Lip Ht (in)	N/A	N/A	Gutter X Slope (%)	N/A
N/A	Painted X Walk1?	No	N/A	Painted X Walk2?	No
	X Walk 1 Direction	To SE		X Walk 2 Direction	To NE
N/A	X Walk 1 Width (in)	N/A	N/A	X Walk 2 Width (in)	N/A
	X Walk 1 Slope (%)	3.3		X Walk 2 Slope (%)	4.6
	X Walk 1 X Slope (%)	6.5		X Walk 2 X Slope (%)	2.3

N/A	Ramp inside XWalk1?	N/A	N/A	Ramp inside XWalk2?	N/A
	Road Slope (%)	2.7	N/A	Clear Space?	N/A
	Road X Slope (%)	5.2	N/A	Clear Space to XWalk (in)	N/A
N/A	Any Obstructions?	N/A	N/A	Storm Grate/Utility Hazard?	N/A
	Obstruction Type			Storm Grate/Utility Type	
		N/A			N/A
			Yes	Surface Condition? (G/P)	Good

**Remove & Replace Curb Ramp With Two New Directional Ramps or Equivalent.**

Total Cost: \$ 3200.00
