Access Compliance Report Public Rights-of-Way (Curb Ramps)

Location: Intersection ID: 13476 Main Street: ELIZABETH AV **Cross Street: PEASE LN**

Ramp Type: Perp Initial Pass/Fail: Pass **Overall Compliance: No** ADA ID: EDD6365AC458 Severity Score: 25.25

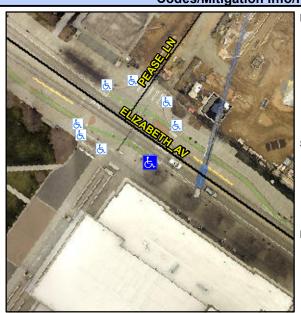
Compliance Description		Data	Compliance		Description
N/A	Ramp Length (in)	80.0	Yes	Ramp Slope (%)	
Yes	Ramp Width (in)	48.5	No	Ram	o XSlope (%)
N/A	Flare Type LT	Sloped	N/A	Flare	Type RT
N/A	Flare Slope LT (%)	39.8	Yes	Flare	Slope RT (%)
N/A	Flare Traversable LT?	Yes	N/A	Flare	Traversable R
Yes	Landing Length (in)	61.1	Yes	DWS	Provided?
Yes	Landing Width (in)	48.5	Yes	DWS	Contrast?
No	Landing Slope (%)	2.2	Yes	DWS	Length (in)
Yes	Landing X Slope (%)	3.1	Yes	DWS	Full Width?
N/A	Landing Curb? (Y/N)	No	Yes	DWS	Offset (in)
N/A	Shared Landing?	No			
Yes	Gutter Ponding?	No	Yes	Gutte	er Slope (%)
Yes	Gutter Lip Ht (in)	0.0	Yes	Gutte	er X Slope (%)
N/A	Painted X Walk1?	Yes	N/A	Paint	ed X Walk2?
	X Walk 1 Direction	To NE		X Wa	lk 2 Direction
N/A	X Walk 1 Width (in)	145.0	N/A	X Wa	ılk 2 Width (in)
	X Walk 1 Slope (%)	1.1		X Wa	ılk 2 Slope (%)
	X Walk 1 X Slope (%)	3.9		X Wa	ılk 2 X Slope (%
Yes	Ramp inside XWalk1?	Yes	N/A	Ram	p inside XWalk

Road Slope (%)	N/A	N/A	Clear	Space?
	Road X Slope (%)	N/A	N/A	Clear	Space to XWa
No	Any Obstructions?	Yes	No	Storn	n Grate/Utility I
	Obstruction Type			Storn	n Grate/Utility 1
	XWALK	POST 39.0			
			Yes	Surfa	ce Condition?

Clear Space to XWalk (in) N/A Storm Grate/Utility Hazard? No Storm Grate/Utility Type N/A Surface Condition? (G/P) Good Yes

ELIZABETH AV Street 1 Name Stop Condition-Street 2 Signal Street 2 Name N/A Stop Condition-Street 1 N/A Possible Solutions: Remove & Replace Entire Ramp. Relocate Obstruction. Surveyor Notes: N/A PROW/ADA: Not Found, R304.5.3, R304.2.2-Perp, R304.3.2-Para, R304.2.3, R302.3, R402.2
