Intersection ID: 10031127	Main Street: MARGARET_WALLACE_RD	Cross Street: N/A	Location:	S
ADA ID: EDDDB8E50FF43	Ramp Type: Perp	Initial Pass/Fail: Fail	Overall Compliance: No	Severity Score: 8.75

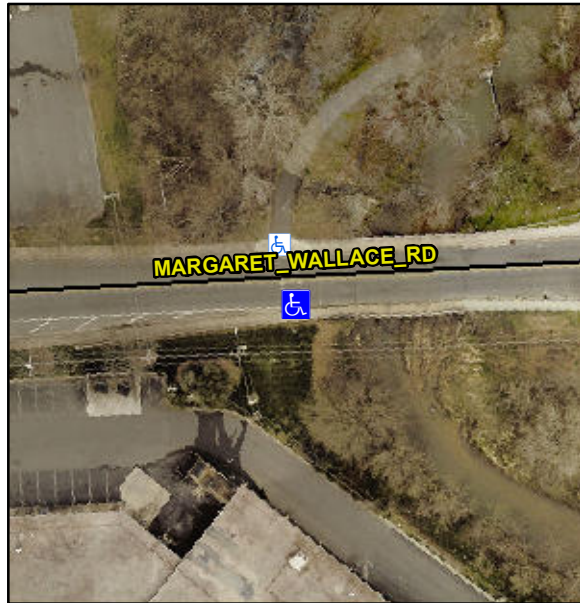
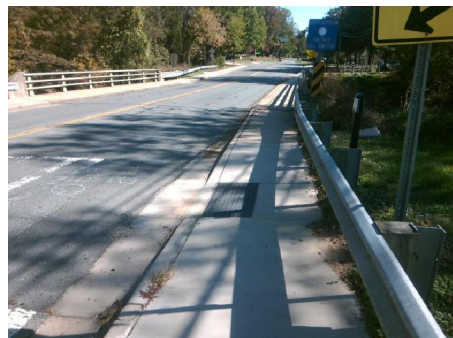
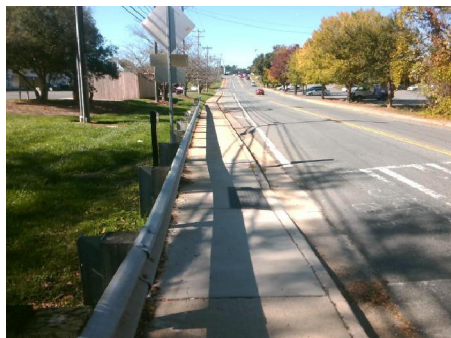
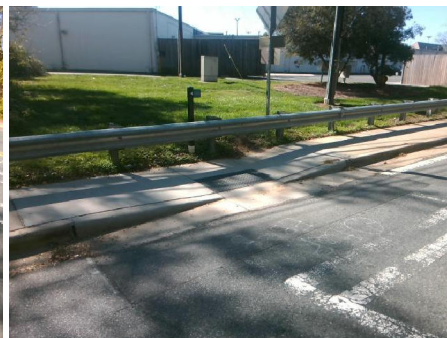
**Not Found, R304.5.1**

Compliance	Description	Data	Compliance	Description	Data
N/A	Ramp Length (in)	58.0	Yes	Ramp Slope (%)	7.6
No	Ramp Width (in)	46.0	Yes	Ramp XSlope (%)	0.8
N/A	Flare Type LT	N/A	N/A	Flare Type RT	N/A
N/A	Flare Slope LT (%)	N/A	N/A	Flare Slope RT (%)	N/A
N/A	Flare Traversable LT?	N/A	N/A	Flare Traversable RT?	N/A
N/A	Landing Length (in)	N/A	N/A	DWS Provided?	N/A
N/A	Landing Width (in)	N/A	N/A	DWS Contrast?	N/A
N/A	Landing Slope (%)	N/A	N/A	DWS Length (in)	N/A
N/A	Landing X Slope (%)	N/A	N/A	DWS Full Width?	N/A
N/A	Landing Curb? (Y/N)	N/A	N/A	DWS Offset (in)	N/A
N/A	Shared Landing?	N/A			
N/A	Gutter Ponding?	N/A	N/A	Gutter Slope (%)	N/A
N/A	Gutter Lip Ht (in)	N/A	N/A	Gutter X Slope (%)	N/A
N/A	Painted X Walk1?	Yes	N/A	Painted X Walk2?	N/A
	X Walk 1 Direction	To N		X Walk 2 Direction	N/A
N/A	X Walk 1 Width (in)	112.0	N/A	X Walk 2 Width (in)	N/A
	X Walk 1 Slope (%)	6.6		X Walk 2 Slope (%)	N/A
	X Walk 1 X Slope (%)	0.7		X Walk 2 X Slope (%)	N/A

N/A	Ramp inside XWalk1?	Yes	N/A	Ramp inside XWalk2?	N/A
	Road Slope (%)	N/A	N/A	Clear Space?	N/A
	Road X Slope (%)	N/A	N/A	Clear Space to XWalk (in)	N/A
N/A	Any Obstructions?	N/A	N/A	Storm Grate/Utility Hazard?	N/A
	Obstruction Type			Storm Grate/Utility Type	
		N/A			N/A
			Yes	Surface Condition? (G/P)	Good

### Remove & Replace Entire Ramp.

Total Cost: \$ 1850.00
