Access Compliance Report

Public Rights-of-Way

(Curb Ramps)

Intersection ID: N/A	Main Street: NATIONS_FORD_RD	Cross Street: N/A	Location: W
ADA ID: EDDD197B0A29	Ramp Type: PerpDiag	Initial Pass/Fail: Fail	Overall Compliance: No
Codes/Mitigation Info/Possible Solution		Field Measurements/Component Compliance	
Severity Score: 12.5

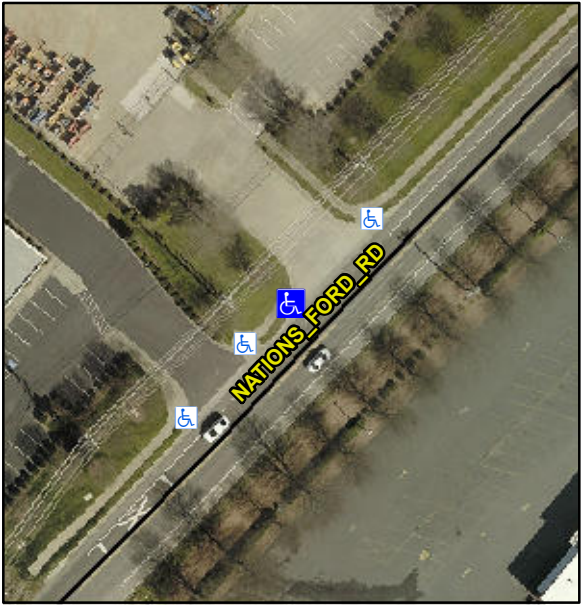
Possible Solutions:		Compliance		Description		Data	Compliance	Description	Data
	Remove & Replace Curb Ramp With Two New Directional Ramps or Equivalent.		N/A		Ramp Length (in)		48.0	No	Ramp Slope (%)	9.2
<p>Surveyor Notes:</p> <p>N/A</p> <p>PROW/ADA:</p> <p>R304.2.2</p>			Yes		Ramp Width (in)		52.0	Yes	Ramp XSlope (%)	0.3
			N/A		Flare Type LT		N/A	N/A	Flare Type RT	N/A
<p>Street 1 Name</p> <p>NATIONS FORD RD</p> <p>Stop Condition-Street 2</p> <p>None</p> <p>Street 2 Name</p> <p>ENTRANCE</p> <p>Stop Condition-Street 1</p> <p>None</p>			N/A		Flare Slope LT (%)		N/A	N/A	Flare Slope RT (%)	N/A
			N/A		Flare Traversable LT?		N/A	N/A	Flare Traversable RT?	N/A
<p>Total Cost:</p> <p>\$ 3200.00</p>			N/A		Landing Length (in)		N/A	N/A	DWS Provided?	N/A
			N/A		Landing Width (in)		N/A	N/A	DWS Contrast?	N/A
			N/A		Landing Slope (%)		N/A	N/A	DWS Length (in)	N/A
			N/A		Landing X Slope (%)		N/A	N/A	DWS Full Width?	N/A
