## **Access Compliance Report Public Rights-of-Way** (Curb Ramps)

Intersection ID: 18128 Main Street: BRANDYWINE RD Cross Street: HILLSDALE AV Location: NE **Overall Compliance: No Severity Score:** ADA ID: EDE822886714 Ramp Type: PerpDiag Initial Pass/Fail: Fail 37.5

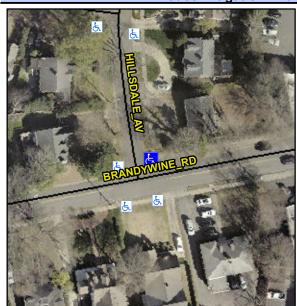
Compliance Description Data Compliance Description Data No N/A Ramp Length (in) 122.0 Ramp Slope (%) 9.7 49.0 No Ramp XSlope (%) Yes Ramp Width (in) 9.4 N/A N/A Flare Type LT N/A Flare Type RT N/A N/A N/A N/A Flare Slope RT (%) N/A Flare Slope LT (%) N/A Flare Traversable LT? N/A N/A Flare Traversable RT? N/A N/A N/A N/A **DWS Provided?** N/A Landing Length (in) N/A Landing Width (in) N/A N/A **DWS Contrast?** N/A N/A N/A N/A Landing Slope (%) DWS Length (in) N/A N/A Landing X Slope (%) N/A N/A DWS Full Width? N/A N/A Landing Curb? (Y/N) N/A N/A DWS Offset (in) N/A N/A N/A Shared Landing? N/A **Gutter Ponding?** N/A N/A Gutter Slope (%) N/A N/A Gutter Lip Ht (in) N/A N/A Gutter X Slope (%) N/A N/A Painted X Walk1? No N/A Painted X Walk2? No X Walk 1 Direction To W X Walk 2 Direction To S N/A N/A X Walk 1 Width (in) N/A X Walk 2 Width (in) N/A X Walk 1 Slope (%) 1.9 X Walk 2 Slope (%) 10.5 X Walk 1 X Slope (%) 10.5 X Walk 2 X Slope (%) 2.3 N/A N/A N/A Ramp inside XWalk2? N/A Ramp inside XWalk1? Road Slope (%) 9.9 N/A Clear Space? N/A N/A Road X Slope (%) 6.7 Clear Space to XWalk (in) N/A N/A N/A Any Obstructions? N/A Storm Grate/Utility Hazard? N/A **Obstruction Type** Storm Grate/Utility Type N/A N/A Yes Surface Condition? (G/P) Good

Possible Solutions: Remove & Replace Curb Ramp With Two New Directional Ramps or Equivalent. Surveyor Notes: N/A PROW/ADA: Not Found, R304.2.2, R304.5.3
