# Access Compliance Report

## Public Rights-of-Way

### (Curb Ramps)

Intersection ID: N/A	Main Street: SOLAR_WY	Cross Street: ROCK_ISLAND_RD	Location: SE
ADA ID: EE08F5766EA0	Ramp Type: Perp	Initial Pass/Fail: Fail	Overall Compliance: No
Severity Score: 12.5			
Codes/Mitigation Info/Possible Solution		Field Measurements/Component Compliance

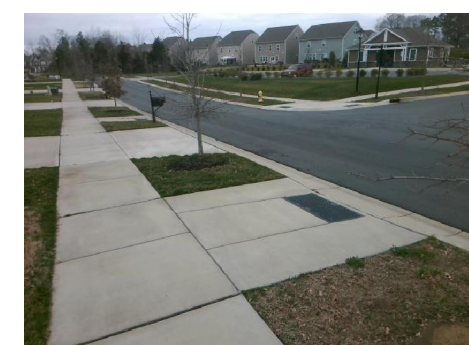
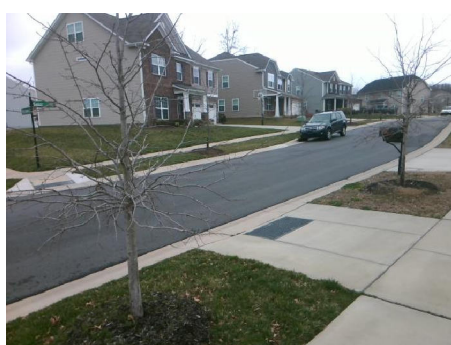
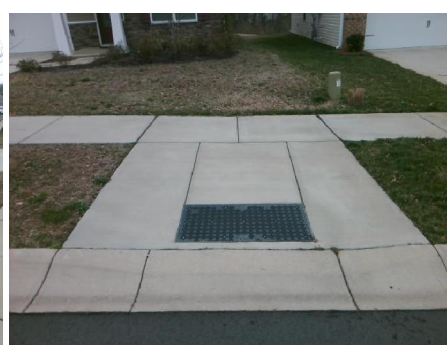
Compliance	Description	Data	Compliance	Description	Data
N/A	Ramp Length (in)	95.0	Yes	Ramp Slope (%)	5.2
Yes	Ramp Width (in)	48.0	No	Ramp XSlope (%)	5.5
N/A	Flare Type LT	N/A	N/A	Flare Type RT	N/A
N/A	Flare Slope LT (%)	N/A	N/A	Flare Slope RT (%)	N/A
N/A	Flare Traversable LT?	N/A	N/A	Flare Traversable RT?	N/A
N/A	Landing Length (in)	N/A	N/A	DWS Provided?	N/A
N/A	Landing Width (in)	N/A	N/A	DWS Contrast?	N/A
N/A	Landing Slope (%)	N/A	N/A	DWS Length (in)	N/A
N/A	Landing X Slope (%)	N/A	N/A	DWS Full Width?	N/A
N/A	Landing Curb? (Y/N)	N/A	N/A	DWS Offset (in)	N/A
N/A	Shared Landing?	N/A			
N/A	Gutter Ponding?	N/A	N/A	Gutter Slope (%)	N/A
N/A	Gutter Lip Ht (in)	N/A	N/A	Gutter X Slope (%)	N/A
N/A	Painted X Walk1?	No	N/A	Painted X Walk2?	N/A
	X Walk 1 Direction	To NW		X Walk 2 Direction	N/A
N/A	X Walk 1 Width (in)	N/A	N/A	X Walk 2 Width (in)	N/A
	X Walk 1 Slope (%)	2.2		X Walk 2 Slope (%)	N/A
	X Walk 1 X Slope (%)	4.4		X Walk 2 X Slope (%)	N/A

N/A	Ramp inside XWalk1?	N/A	N/A	Ramp inside XWalk2?	N/A
	Road Slope (%)	N/A	N/A	Clear Space?	N/A
	Road X Slope (%)	N/A	N/A	Clear Space to XWalk (in)	N/A
N/A	Any Obstructions?	N/A	N/A	Storm Grate/Utility Hazard?	N/A
	Obstruction Type			Storm Grate/Utility Type	
		N/A			N/A
		Yes		Surface Condition? (G/P)	Good

**Remove & Replace Entire Ramp.**

**R304.5.3**
