Access Compliance Report

Public Rights-of-Way

(Curb Ramps)

Intersection ID: 13917	Main Street: MORNINGSIDE_DR	Cross Street: MCCLINTOCK_RD	Location: W
ADA ID: EE0EFD2F5D63	Ramp Type: Perp	Initial Pass/Fail: Fail	Overall Compliance: No
			Severity Score: 13.75

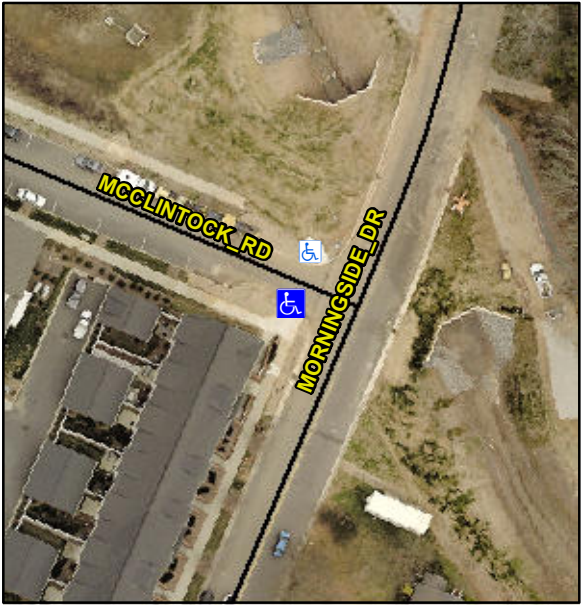
Possible Solutions:		Compliance	Description	Data
	Remove & Replace Entire Ramp.		N/A	Ramp Length (in)	54.5
			Yes	Ramp Width (in)	48.0
			N/A	Flare Type LT	N/A
			N/A	Flare Slope LT (%)	N/A
			N/A	Flare Traversable LT?	N/A
			N/A	Landing Length (in)	N/A
			N/A	Landing Width (in)	N/A
			N/A	Landing Slope (%)	N/A
			N/A	Landing X Slope (%)	N/A
<p>Surveyor Notes:</p> <p>N/A</p> <p>PROW/ADA:</p> <p>Not Found, R304.2.2, R304.5.3</p>			N/A	Flare Type RT	N/A
			N/A	Flare Slope RT (%)	N/A
			N/A	Flare Traversable RT?	N/A
			N/A	DWS Provided?	N/A
			N/A	DWS Contrast?	N/A
			N/A	DWS Length (in)	N/A
			N/A	DWS Full Width?	N/A
			N/A	DWS Offset (in)	N/A
			N/A	Shared Landing?	N/A
			N/A	Gutter Ponding?	N/A
			N/A	Gutter Lip Ht (in)	N/A
			N/A	Painted X Walk1?	No
				X Walk 1 Direction	To N
			N/A	X Walk 1 Width (in)	N/A
				X Walk 1 Slope (%)	0.4

X Walk 1 X Slope (%)	5.7
			N/A	Ramp inside XWalk1?	N/A
				Road Slope (%)	N/A
				Road X Slope (%)	N/A
			N/A	Any Obstructions?	N/A
				Obstruction Type	
Total Cost:			\$	1850.00

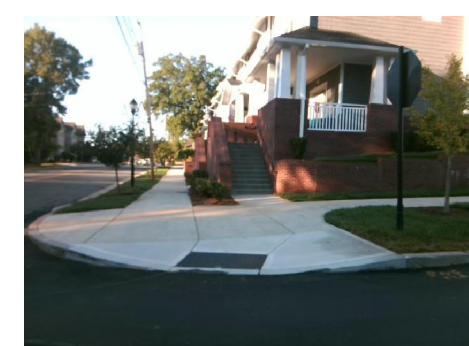
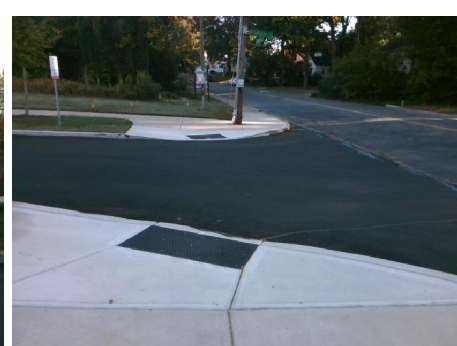
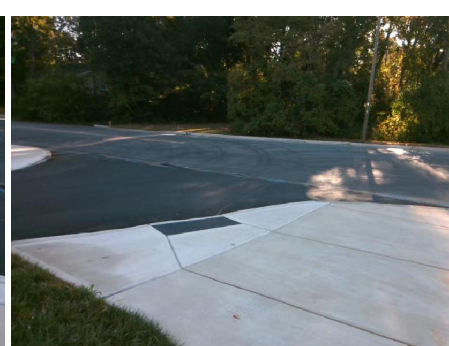
Yes Surface Condition? (G/P) Good
