Access Compliance Report

Public Rights-of-Way

(Curb Ramps)

Intersection ID: 19947	Main Street: CHARTER_PL	Cross Street: THERMAL_RD	Location: SW
ADA ID: EE108333D48B	Ramp Type: ParaDiag	Initial Pass/Fail: Fail	Overall Compliance: No
Codes/Mitigation Info/Possible Solution		Field Measurements/Component Compliance	
Severity Score: 22.5

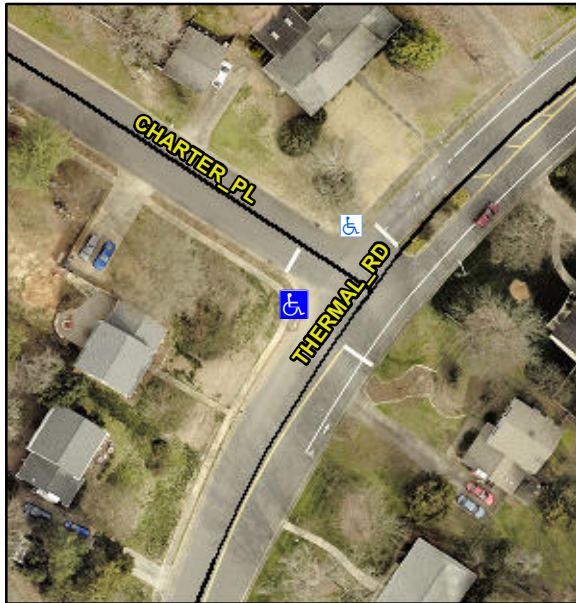
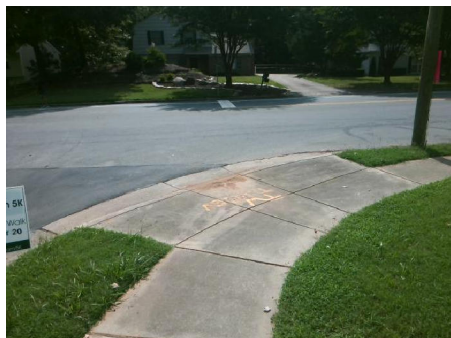
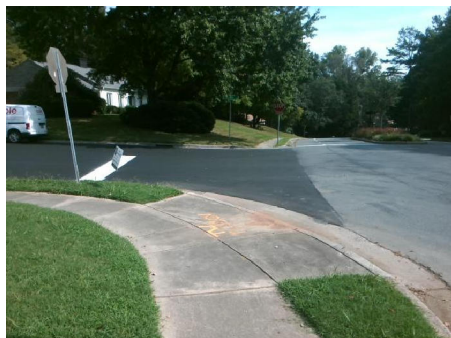
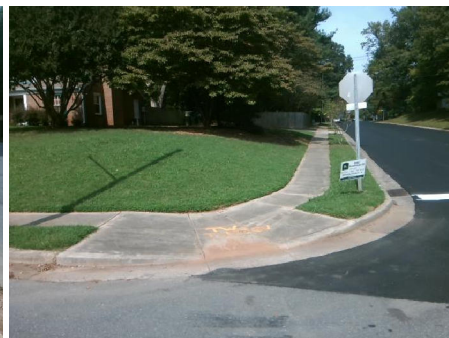
Compliance	Description	Data	Compliance	Description	Data
N/A	Ramp Length LT (in)	55.0	N/A	Ramp Length RT (in)	40.0
No	Ramp Width LT (in)	46.5	Yes	Ramp Width RT (in)	48.0
No	Ramp Slope LT (%)	9.6	Yes	Ramp Slope RT (%)	8.2
No	Ramp XSlope LT (%)	3.5	Yes	Ramp XSlope RT (%)	1.5
N/A	Landing Length (in)	N/A	N/A	DWS Provided?	N/A
N/A	Landing Width (in)	N/A	N/A	DWS Contrast?	N/A
N/A	Landing Slope (%)	N/A	N/A	DWS Length (in)	N/A
N/A	Landing X Slope (%)	N/A	N/A	DWS Full Width?	N/A
N/A	Landing Curb? (Y/N)	N/A	N/A	DWS Offset (in)	N/A
N/A	Shared Landing?	N/A			
N/A	Gutter Ponding?	N/A	N/A	Gutter Slope (%)	N/A
N/A	Gutter Lip Ht (in)	N/A	N/A	Gutter X Slope (%)	N/A
N/A	Painted X Walk1?	No	N/A	Painted X Walk2?	No
	X Walk 1 Direction	To E		X Walk 2 Direction	To NE
N/A	X Walk 1 Width (in)	N/A	N/A	X Walk 2 Width (in)	N/A
	X Walk 1 Slope (%)	4.7		X Walk 2 Slope (%)	1.4
	X Walk 1 X Slope (%)	0.4		X Walk 2 X Slope (%)	2.3
N/A	Ramp inside XWalk1?	N/A	N/A	Ramp inside XWalk2?	N/A

Road Slope (%)	0.6	N/A	Clear Space?	N/A
	Road X Slope (%)	3.9	N/A	Clear Space to XWalk (in)	N/A
N/A	Any Obstructions?	N/A	N/A	Storm Grate/Utility Hazard?	N/A
	Obstruction Type			Storm Grate/Utility Type	
		N/A			N/A
			Yes	Surface Condition? (G/P)	Good
			N/A	Curb Slope (%)	9.4

Possible Solutions:

Remove & Replace Curb Ramp With Two New Directional Ramps or Equivalent.
