Access Compliance Report

Public Rights-of-Way

(Curb Ramps)

Intersection ID: 3248	Main Street: METROMONT INDUSTRIAL_BV	Cross Street: METROMONT_PY	Location: NW
ADA ID: EE181DC55E26	Ramp Type: Perp	Initial Pass/Fail: Fail	Overall Compliance: No
Severity Score: 33.75			
Codes/Mitigation Info/Possible Solution		Field Measurements/Component Compliance

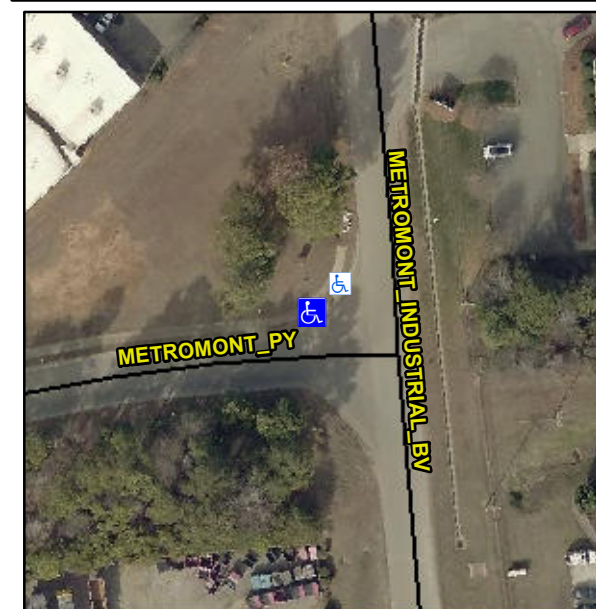
Compliance	Description	Data	Compliance	Description	Data
N/A	Ramp Length (in)	50.0	No	Ramp Slope (%)	12.8
No	Ramp Width (in)	44.5	Yes	Ramp XSlope (%)	0.6
N/A	Flare Type LT	N/A	N/A	Flare Type RT	N/A
N/A	Flare Slope LT (%)	N/A	N/A	Flare Slope RT (%)	N/A
N/A	Flare Traversable LT?	N/A	N/A	Flare Traversable RT?	N/A
N/A	Landing Length (in)	N/A	N/A	DWS Provided?	N/A
N/A	Landing Width (in)	N/A	N/A	DWS Contrast?	N/A
N/A	Landing Slope (%)	N/A	N/A	DWS Length (in)	N/A
N/A	Landing X Slope (%)	N/A	N/A	DWS Full Width?	N/A
N/A	Landing Curb? (Y/N)	N/A	N/A	DWS Offset (in)	N/A
N/A	Shared Landing?	N/A			
N/A	Gutter Ponding?	N/A	N/A	Gutter Slope (%)	N/A
N/A	Gutter Lip Ht (in)	N/A	N/A	Gutter X Slope (%)	N/A
N/A	Painted X Walk1?	No	N/A	Painted X Walk2?	N/A
	X Walk 1 Direction	To S		X Walk 2 Direction	N/A
N/A	X Walk 1 Width (in)	N/A	N/A	X Walk 2 Width (in)	N/A
	X Walk 1 Slope (%)	4.9		X Walk 2 Slope (%)	N/A
	X Walk 1 X Slope (%)	0.5		X Walk 2 X Slope (%)	N/A

N/A	Ramp inside XWalk1?	N/A	N/A	Ramp inside XWalk2?	N/A
	Road Slope (%)	N/A	N/A	Clear Space?	N/A
	Road X Slope (%)	N/A	N/A	Clear Space to XWalk (in)	N/A
N/A	Any Obstructions?	N/A	N/A	Storm Grate/Utility Hazard?	N/A
	Obstruction Type			Storm Grate/Utility Type	
		N/A			N/A
			Yes	Surface Condition? (G/P)	Good

Possible Solutions:

Remove & Replace Entire Ramp.

R304.5.1, R304.2.2
