Access Compliance Report Public Rights-of-Way (Curb Ramps)

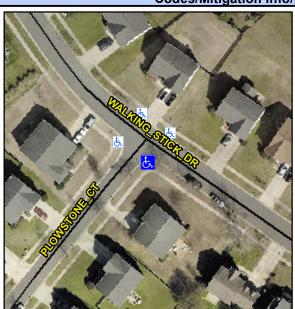
Intersection ID: 30481 Main Street: PLOWSTONE_CT Cross Street: WALKING_STICK_DR Location: S

Total Cost: \$ 3200.00

Compliance Description		Data	Compliance Description		Data	
N/A	Ramp Length (in)	83.0	No	Ramp Slope (%)	8.6	
Yes	Ramp Width (in)	92.0	No	Ramp XSlope (%)	8.2	
N/A	Flare Type LT	N/A	N/A	Flare Type RT	N/A	
N/A	Flare Slope LT (%)	N/A	N/A	Flare Slope RT (%)	N/A	
N/A	Flare Traversable LT?	N/A	N/A	Flare Traversable RT?	N/A	
N/A	Landing Length (in)	N/A	N/A	DWS Provided?	N/A	
N/A	Landing Width (in)	N/A	N/A	DWS Contrast?	N/A	
N/A	Landing Slope (%)	N/A	N/A	DWS Length (in)	N/A	
N/A	Landing X Slope (%)	N/A	N/A	DWS Full Width?	N/A	
N/A	Landing Curb? (Y/N)	N/A	N/A	DWS Offset (in)	N/A	
N/A	Shared Landing?	N/A				
N/A	Gutter Ponding?	N/A	N/A	Gutter Slope (%)	N/A	
N/A	Gutter Lip Ht (in)	N/A	N/A	Gutter X Slope (%)	N/A	
N/A	Painted X Walk1?	No	N/A	Painted X Walk2?	No	
	X Walk 1 Direction	To NE		X Walk 2 Direction	To NW	
N/A	X Walk 1 Width (in)	N/A	N/A	X Walk 2 Width (in)	N/A	
	X Walk 1 Slope (%)	6.0		X Walk 2 Slope (%)	1.6	
	X Walk 1 X Slope (%)	2.6		X Walk 2 X Slope (%)	6.2

WALKING STICK DR None PLOWSTONE CT StopSign Possible Solutions:

PROW/ADA:
