Access Compliance Report

Public Rights-of-Way

(Curb Ramps)

Intersection ID: 18963	Main Street: GROVER_RD	Cross Street: SOUTH_BV	Location: NE
ADA ID: EE283E48F630	Ramp Type: PerpDiag	Initial Pass/Fail: Fail	Overall Compliance: No
Severity Score: 25			
Codes/Mitigation Info/Possible Solution		Field Measurements/Component Compliance

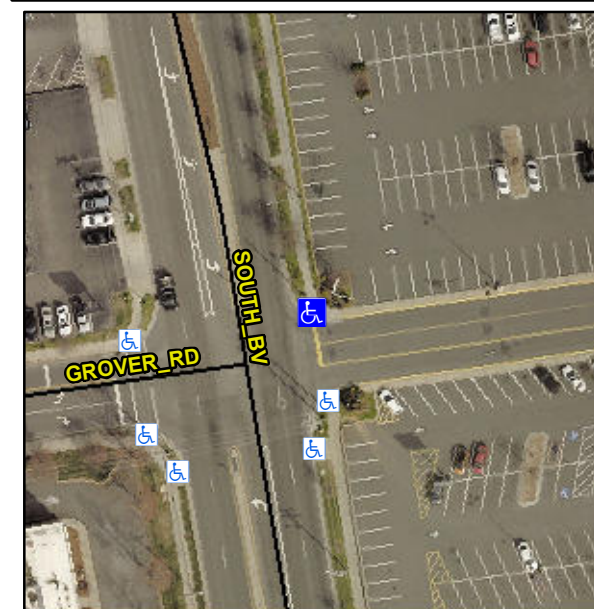
Not Found, R304.5.3

Compliance	Description	Data	Compliance	Description	Data
N/A	Ramp Length (in)	88.0	Yes	Ramp Slope (%)	8.1
Yes	Ramp Width (in)	48.0	No	Ramp XSlope (%)	10.2
N/A	Flare Type LT	N/A	N/A	Flare Type RT	N/A
N/A	Flare Slope LT (%)	N/A	N/A	Flare Slope RT (%)	N/A
N/A	Flare Traversable LT?	N/A	N/A	Flare Traversable RT?	N/A
N/A	Landing Length (in)	N/A	N/A	DWS Provided?	N/A
N/A	Landing Width (in)	N/A	N/A	DWS Contrast?	N/A
N/A	Landing Slope (%)	N/A	N/A	DWS Length (in)	N/A
N/A	Landing X Slope (%)	N/A	N/A	DWS Full Width?	N/A
N/A	Landing Curb? (Y/N)	N/A	N/A	DWS Offset (in)	N/A
N/A	Shared Landing?	N/A			
N/A	Gutter Ponding?	N/A	N/A	Gutter Slope (%)	N/A
N/A	Gutter Lip Ht (in)	N/A	N/A	Gutter X Slope (%)	N/A
N/A	Painted X Walk1?	No	N/A	Painted X Walk2?	No
	X Walk 1 Direction	To W		X Walk 2 Direction	To S
N/A	X Walk 1 Width (in)	N/A	N/A	X Walk 2 Width (in)	N/A
	X Walk 1 Slope (%)	1.4		X Walk 2 Slope (%)	0.5
	X Walk 1 X Slope (%)	2.7		X Walk 2 X Slope (%)	4.1

N/A	Ramp inside XWalk1?	N/A	N/A	Ramp inside XWalk2?	N/A
	Road Slope (%)	3.3	N/A	Clear Space?	N/A
	Road X Slope (%)	2.1	N/A	Clear Space to XWalk (in)	N/A
N/A	Any Obstructions?	N/A	N/A	Storm Grate/Utility Hazard?	N/A
	Obstruction Type			Storm Grate/Utility Type	
		N/A			N/A
		Yes		Surface Condition? (G/P)	Good

Remove & Replace Curb Ramp With Two New Directional Ramps or Equivalent.
