# Access Compliance Report

## Public Rights-of-Way (Curb Ramps)

Intersection ID: 25094	Main Street: GRIMMERSBOROUGH_LN	Cross Street: PROVIDENCE MANOR_RD	Location: SW
ADA ID: EE4242A821A1	Ramp Type: Perp	Initial Pass/Fail: Fail	Overall Compliance: No
		Severity Score: 50

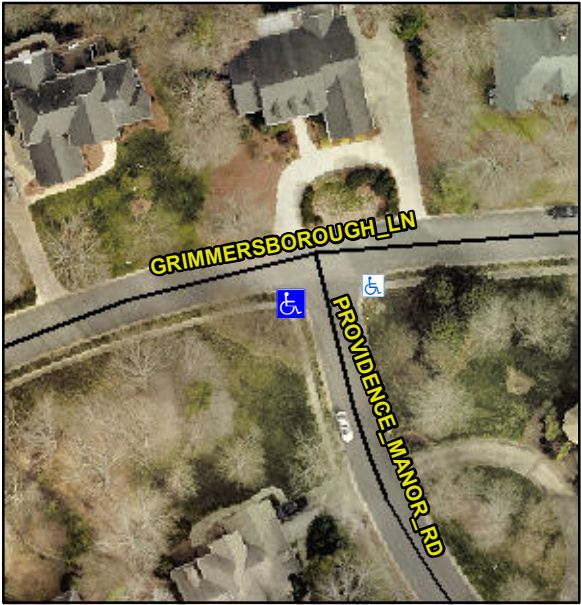
Possible Solutions:		<b>Compliance</b>	<b>Description</b>	<b>Data</b>
	<b>Remove &amp; Replace Entire Ramp.</b>		<b>No</b>	Ramp Length (in)	<b>41.0</b>
			<b>Yes</b>	Ramp Width (in)	<b>48.0</b>
			<b>N/A</b>	Flare Type LT	<b>N/A</b>
			<b>N/A</b>	Flare Slope LT (%)	<b>N/A</b>
			<b>N/A</b>	Flare Traversable LT?	<b>N/A</b>
			<b>N/A</b>	Landing Length (in)	<b>N/A</b>
			<b>N/A</b>	Landing Width (in)	<b>N/A</b>
			<b>N/A</b>	Landing Slope (%)	<b>N/A</b>
			<b>N/A</b>	Landing X Slope (%)	<b>N/A</b>
<p>Surveyor Notes:</p> <p><b>N/A</b></p> <p>PROW/ADA:</p> <p><b>Not Found, R304.2.2, R304.5.3</b></p>			<b>N/A</b>	Flare Type RT	<b>N/A</b>
			<b>N/A</b>	Flare Slope RT (%)	<b>N/A</b>
			<b>N/A</b>	Flare Traversable RT?	<b>N/A</b>
			<b>N/A</b>	DWS Provided?	<b>N/A</b>
			<b>N/A</b>	DWS Contrast?	<b>N/A</b>
			<b>N/A</b>	DWS Length (in)	<b>N/A</b>

<b>N/A</b>	DWS Full Width?	<b>N/A</b>
			<b>N/A</b>	DWS Offset (in)	<b>N/A</b>
			<b>N/A</b>	Gutter Ponding?	<b>N/A</b>
			<b>N/A</b>	Gutter Lip Ht (in)	<b>N/A</b>
			<b>No</b>	Painted X Walk1?	<b>N/A</b>
				X Walk 1 Direction	<b>To E</b>
			<b>N/A</b>	X Walk 1 Width (in)	<b>N/A</b>
			<b>6.6</b>	X Walk 1 Slope (%)	<b>N/A</b>
			<b>4.4</b>	X Walk 1 X Slope (%)	<b>N/A</b>
			<b>N/A</b>	Ramp inside XWalk1?	<b>N/A</b>
			<b>N/A</b>	Road Slope (%)	<b>N/A</b>
			<b>N/A</b>	Road X Slope (%)	<b>N/A</b>
			<b>N/A</b>	Any Obstructions?	<b>N/A</b>
				Obstruction Type	
Total Cost: \$ 1850.00			<b>N/A</b>	Storm Grate/Utility Hazard?	<b>N/A</b>
			<b>N/A</b>	Storm Grate/Utility Type	<b>N/A</b>
			<b>Yes</b>	Surface Condition? (G/P)	<b>Good</b>
