Access Compliance Report

Public Rights-of-Way (Curb Ramps)

Intersection ID: 50516	Main Street: MICHAEL_CROSSING_DR	Cross Street: MCLEAN_RD	Location: NW
ADA ID: EE4CFE81A32D	Ramp Type: Combination2	Initial Pass/Fail: Fail	Overall Compliance: No
		Severity Score: 35

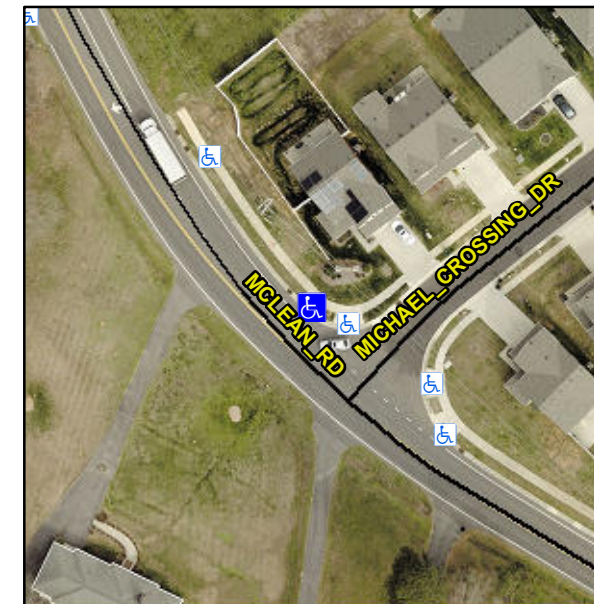
RT RP < 5%

Not Found, R304.5.1, R304.3.2, R304.5.3

Compliance	Description	Data	Compliance	Description	Data
N/A	Ramp Length LT (in)	53.0	N/A	Ramp Length RT (in)	47.5
Yes	Ramp Width LT (in)	60.0	N/A	Ramp Width RT (in)	59.5
No	Ramp Slope LT (%)	12.0	N/A	Ramp Slope RT (%)	1.2
No	Ramp XSlope LT (%)	2.1	N/A	Ramp XSlope RT (%)	2.5
N/A	Ramp Length (in)	61.0	Yes	Ramp Slope (%)	1.7
No	Ramp Width (in)	47.5	Yes	Ramp XSlope (%)	3.7
N/A	Flare Type LT	N/A	N/A	Flare Type RT	N/A
N/A	Flare Slope LT (%)	N/A	N/A	Flare Slope RT (%)	N/A
N/A	Flare Traversable LT?	N/A	N/A	Flare Traversable RT?	N/A
N/A	Landing Length (in)	N/A	N/A	DWS Provided?	N/A
N/A	Landing Width (in)	N/A	N/A	DWS Contrast?	N/A
N/A	Landing Slope (%)	N/A	N/A	DWS Length (in)	N/A
N/A	Landing X Slope (%)	N/A	N/A	DWS Full Width?	N/A
N/A	Landing Curb? (Y/N)	N/A	N/A	DWS Offset (in)	N/A
N/A	Shared Landing?	N/A			
N/A	Gutter Ponding?	N/A	N/A	Gutter Slope (%)	N/A
N/A	Gutter Lip Ht (in)	N/A	N/A	Gutter X Slope (%)	N/A
N/A	Painted X Walk1?	No	N/A	Painted X Walk2?	N/A

X Walk 1 Direction	To SW		X Walk 2 Direction	N/A
	X Walk 1 Width (in)	N/A		X Walk 2 Width (in)	N/A
	X Walk 1 Slope (%)	5.3		X Walk 2 Slope (%)	N/A
	X Walk 1 X Slope (%)	5.5		X Walk 2 X Slope (%)	N/A
N/A	Ramp inside XWalk1?	N/A	N/A	Ramp inside XWalk2?	N/A
	Road Slope (%)	N/A		Clear Space?	N/A
	Road X Slope (%)	N/A	N/A	Clear Space to XWalk (in)	N/A
			N/A	Any Obstruction?	N/A
				Obstruction Type	N/A
			N/A	Storm Grate/Utility Hazard?	N/A
				Storm Grate/Utility Type	N/A
			Yes	Surface Condition? (G/P)	Good
				Curb Slope (%)	6.0

Remove & Replace Entire Ramp.
