## **Access Compliance Report Public Rights-of-Way** (Curb Ramps)

Intersection ID: 20760 Main Street: SHARON RD **Cross Street: SHARON VIEW RD** Location: SW **ADA ID: EE4EF35EDDFA** Ramp Type: BlendTrans2 Initial Pass/Fail: Fail **Overall Compliance: No Severity Score:** 8.75

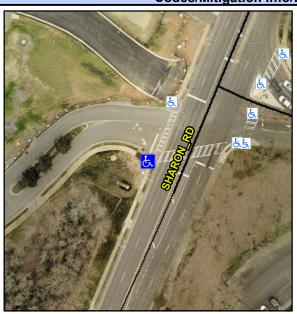
Compliance Description Data		Compliance Description		Data	
N/A	Ramp Length (in)	96.0	Yes	BlendTrans Slope (%)	3.0
No	Ramp Width (in)	41.0	Yes	BlendTrans XSlope (%)	1.9
N/A	Flare Type LT	N/A	N/A	Flare Type RT	N/A
N/A	Flare Slope LT (%)	N/A	N/A	Flare Slope RT (%)	N/A
N/A	Flare Traversable LT?	N/A	N/A	Flare Traversable RT?	N/A
N/A	Landing Length (in)	N/A	N/A	DWS Provided?	N/A
N/A	Landing Width (in)	N/A	N/A	DWS Contrast?	N/A
N/A	Landing Slope (%)	N/A	N/A	DWS Length (in)	N/A
N/A	Landing X Slope (%)	N/A	N/A	DWS Full Width?	N/A
N/A	Landing Curb? (Y/N)	N/A	N/A	DWS Offset (in)	N/A
N/A	Shared Landing?	N/A			
N/A	Gutter Ponding?	N/A	N/A	Gutter Slope (%)	N/A
N/A	Gutter Lip Ht (in)	N/A	N/A	Gutter X Slope (%)	N/A
N/A	Painted X Walk1?	Yes	N/A	Painted X Walk2?	Yes
	X Walk 1 Direction	To NE		X Walk 2 Direction	To N
	X Walk 1 Width (in)	118.0		X Walk 2 Width (in)	69.0
	X Walk 1 Slope (%)	0.9		X Walk 2 Slope (%)	1.5
	X Walk 1 X Slope (%)	1.8		X Walk 2 X Slope (%)	2.3

N/A	Ramp inside XWalk1?	Yes	N/A	Ramp inside XWalk2?	No
	Road Slope (%)	0.7		Clear Space?	N/A
	Road X Slope (%)	0.7	N/A	Clear Space to XWalk (in)	N/A
N/A	Any Obstructions?	N/A	N/A	Storm Grate/Utility Hazard?	N/A
	Obstruction Type			Storm Grate/Utility Type	
		N/A			N/A
			Yes	Surface Condition? (G/P)	Good

No

Curb Slope (%)

16.1

Possible Solutions: Remove & Replace Curb Ramp With Two New Directional Ramps or Equivalent. Restripe Crosswalk. Surveyor Notes: N/A PROW/ADA: Not Found, R304.5.1
