Intersection ID: 13428	Main Street: MAYFAIR_AV	Cross Street: OCRACOCKE_ST	Location:	E
ADA ID: EE59FB403780	Ramp Type: PerpDiag	Initial Pass/Fail: Fail	Overall Compliance: No	Severity Score: 13.75

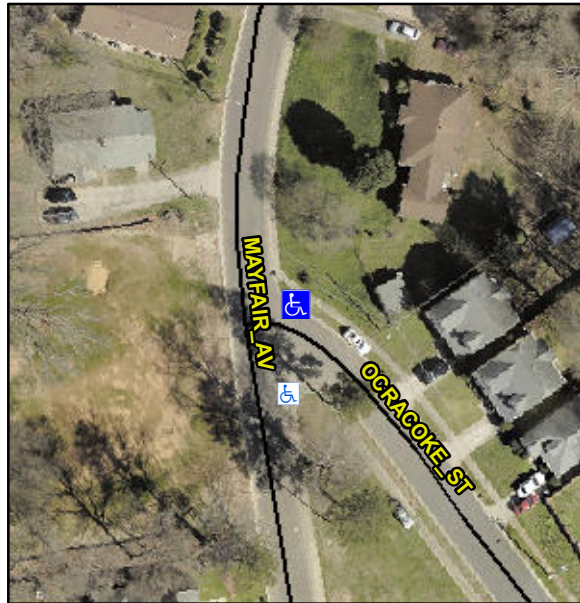
Not Found, R304.2.2, R304.5.3

Compliance	Description	Data	Compliance	Description	Data
N/A	Ramp Length (in)	61.0	No	Ramp Slope (%)	11.3
Yes	Ramp Width (in)	49.0	No	Ramp XSlope (%)	2.7
N/A	Flare Type LT	N/A	N/A	Flare Type RT	N/A
N/A	Flare Slope LT (%)	N/A	N/A	Flare Slope RT (%)	N/A
N/A	Flare Traversable LT?	N/A	N/A	Flare Traversable RT?	N/A
N/A	Landing Length (in)	N/A	N/A	DWS Provided?	N/A
N/A	Landing Width (in)	N/A	N/A	DWS Contrast?	N/A
N/A	Landing Slope (%)	N/A	N/A	DWS Length (in)	N/A
N/A	Landing X Slope (%)	N/A	N/A	DWS Full Width?	N/A
N/A	Landing Curb? (Y/N)	N/A	N/A	DWS Offset (in)	N/A
N/A	Shared Landing?	N/A			
N/A	Gutter Ponding?	N/A	N/A	Gutter Slope (%)	N/A
N/A	Gutter Lip Ht (in)	N/A	N/A	Gutter X Slope (%)	N/A
N/A	Painted X Walk1?	No	N/A	Painted X Walk2?	No
	X Walk 1 Direction	To W		X Walk 2 Direction	To S
N/A	X Walk 1 Width (in)	N/A	N/A	X Walk 2 Width (in)	N/A
	X Walk 1 Slope (%)	0.4		X Walk 2 Slope (%)	1.4
	X Walk 1 X Slope (%)	3.6		X Walk 2 X Slope (%)	1.7

N/A	Ramp inside XWalk1?	N/A	N/A	Ramp inside XWalk2?	N/A
	Road Slope (%)	2.6	N/A	Clear Space?	N/A
	Road X Slope (%)	4.5	N/A	Clear Space to XWalk (in)	N/A
N/A	Any Obstructions?	N/A	N/A	Storm Grate/Utility Hazard?	N/A
	Obstruction Type			Storm Grate/Utility Type	
		N/A			N/A
			Yes	Surface Condition? (G/P)	Good

Possible Solutions:

Remove & Replace Curb Ramp With Two New Directional Ramps or Equivalent.
