## **Access Compliance Report Public Rights-of-Way** (Curb Ramps)

Intersection ID: 27907 Main Street: BAY\_HILL\_CLUB\_DR Cross Street: COLONIAL\_COUNTRY\_LN Location: NW ADA ID: EE659BC9AA43 Ramp Type: Perp Initial Pass/Fail: Pass **Overall Compliance: No Severity Score:** 20

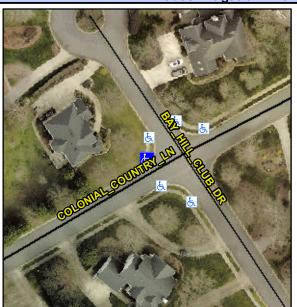
Field Measurements/Component Compliance								
Comp	liance Description	Data	Comp	liance	Description	Data		
N/A	Ramp Length (in)	94.0	Yes	Ramp	Slope (%)	5.1		
Yes	Ramp Width (in)	64.0	Yes	Ramp	XSlope (%)	1.2		
N/A	Flare Type LT	Sloped	N/A	Flare	Type RT	N/A		
N/A	Flare Slope LT (%)	1.1	N/A	Flare	Slope RT (%)	0.9		
N/A	Flare Traversable LT?	No	N/A	Flare	Traversable RT?	No		
No	Landing Length (in)	N/A	No	DWS	Provided?	No		
No	Landing Width (in)	N/A	N/A	DWS	Contrast?	No		
No	Landing Slope (%)	N/A	N/A	DWS	Length (in)	N/A		
No	Landing X Slope (%)	N/A	N/A	DWS	Full Width?	No		
N/A	Landing Curb? (Y/N)	No	N/A	DWS	Offset (in)	N/A		
N/A	Shared Landing?	No						
Yes	Gutter Ponding?	No	Yes	Gutte	r Slope (%)	1.8		
Yes	Gutter Lip Ht (in)	0.0	Yes	Gutte	r X Slope (%)	1.8		
N/A	Painted X Walk1?	No	N/A	Paint	ed X Walk2?	N/A		
	X Walk 1 Direction	To SE		X Wa	lk 2 Direction	N/A		
N/A	X Walk 1 Width (in)	N/A	N/A	X Wa	lk 2 Width (in)	N/A

X Walk 1 Slope (%)	3.8		X Wa	lk 2 Slope (%)	N/A		
	X Walk 1 X Slope (%)	1.1		X Wa	lk 2 X Slope (%)	N/A		
N/A	Ramp inside XWalk1?	N/A	N/A	Ramp	inside XWalk2?	N/A		
	Road Slope (%)	N/A	N/A	Clear	Space?	Yes		
	Road X Slope (%)	N/A	N/A	Clear	Space to XWalk (in)	N/A		
Yes	Any Obstructions?	No	Yes	Storm	n Grate/Utility Hazard?	No		
	Obstruction Type			Storm	n Grate/Utility Type			
		N/A				N/A		
			Yes	Surfa	ce Condition? (G/P)	Good		
	1/12 x 130

· ·	Possible Solutions:	
1	Remove & Replace Entire Ramp.	
ĺ		
100	Surveyor Notes:	
	N/A	
ò		
N. A.	PROW/ADA:	•
8	Not Found, R304.2.1, R304.2.2-Perp,	,
	R304.3.2-Para, R304.5.3, R305
