Access Compliance Report

Public Rights-of-Way

(Curb Ramps)

Intersection ID: 21132	Main Street: W_ARROWOOD_RD	Cross Street: SOUTHERN_PINE_BV	Location: SW
ADA ID: EE6683CF8D7D	Ramp Type: Perp	Initial Pass/Fail: Fail	Overall Compliance: No
Severity Score: 22.5			
Codes/Mitigation Info/Possible Solution		Field Measurements/Component Compliance

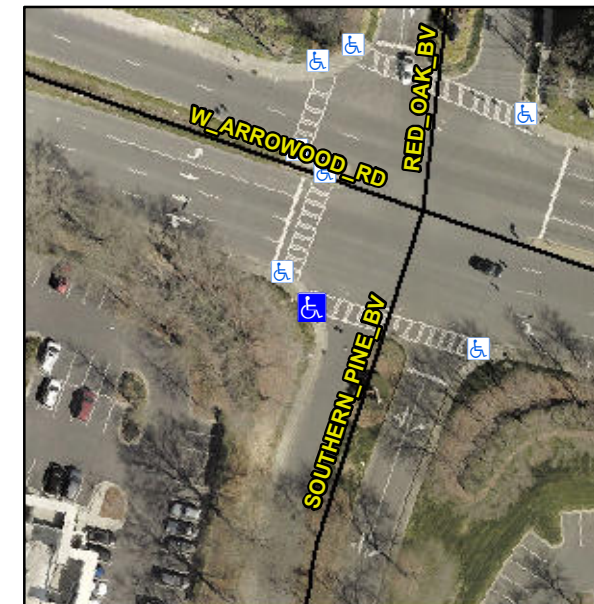
Not Found, R304.5.1, R304.2.2, R304.5.3

Compliance	Description	Data	Compliance	Description	Data
N/A	Ramp Length (in)	72.0	No	Ramp Slope (%)	9.2
No	Ramp Width (in)	43.0	No	Ramp XSlope (%)	4.5
N/A	Flare Type LT	N/A	N/A	Flare Type RT	N/A
N/A	Flare Slope LT (%)	N/A	N/A	Flare Slope RT (%)	N/A
N/A	Flare Traversable LT?	N/A	N/A	Flare Traversable RT?	N/A
N/A	Landing Length (in)	N/A	N/A	DWS Provided?	N/A
N/A	Landing Width (in)	N/A	N/A	DWS Contrast?	N/A
N/A	Landing Slope (%)	N/A	N/A	DWS Length (in)	N/A
N/A	Landing X Slope (%)	N/A	N/A	DWS Full Width?	N/A
N/A	Landing Curb? (Y/N)	N/A	N/A	DWS Offset (in)	N/A
N/A	Shared Landing?	N/A			
N/A	Gutter Ponding?	N/A	N/A	Gutter Slope (%)	N/A
N/A	Gutter Lip Ht (in)	N/A	N/A	Gutter X Slope (%)	N/A
N/A	Painted X Walk1?	Yes	N/A	Painted X Walk2?	N/A
	X Walk 1 Direction	To SE		X Walk 2 Direction	N/A
N/A	X Walk 1 Width (in)	111.0	N/A	X Walk 2 Width (in)	N/A
	X Walk 1 Slope (%)	3.5		X Walk 2 Slope (%)	N/A
	X Walk 1 X Slope (%)	2.2		X Walk 2 X Slope (%)	N/A

N/A	Ramp inside XWalk1?	Yes	N/A	Ramp inside XWalk2?	N/A
	Road Slope (%)	N/A	N/A	Clear Space?	N/A
	Road X Slope (%)	N/A	N/A	Clear Space to XWalk (in)	N/A
N/A	Any Obstructions?	N/A	N/A	Storm Grate/Utility Hazard?	N/A
	Obstruction Type			Storm Grate/Utility Type	
		N/A			N/A
		Yes		Surface Condition? (G/P)	Good

Possible Solutions:

Remove & Replace Entire Ramp.
