Access Compliance Report

Public Rights-of-Way

(Curb Ramps)

Intersection ID: 9810	Main Street: BRIDGEPORT_DR	Cross Street: THE_PLAZA	Location:	NW
ADA ID: EE7B5D413C9F	Ramp Type: Perp	Initial Pass/Fail: Fail	Overall Compliance: No	Severity Score: 25

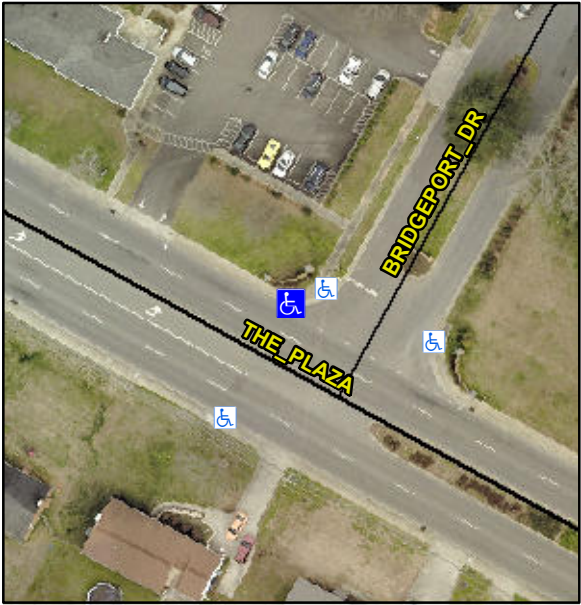
Possible Solutions:		Compliance	Description	Data
	Remove & Replace Entire Ramp.		N/A	Ramp Length (in)	59.5
			Yes	Ramp Width (in)	48.0
			N/A	Flare Type LT	N/A
			N/A	Flare Slope LT (%)	N/A
			N/A	Flare Traversable LT?	N/A
			N/A	Landing Length (in)	N/A
			N/A	Landing Width (in)	N/A
			N/A	Landing Slope (%)	N/A
			N/A	Landing X Slope (%)	N/A
<p>Surveyor Notes:</p> <p>N/A</p> <p>PROW/ADA:</p> <p>Not Found, R304.2.2, R304.5.3</p>			N/A	Flare Type RT	N/A
			N/A	Flare Slope RT (%)	N/A
			N/A	Flare Traversable RT?	N/A
			N/A	DWS Provided?	N/A
			N/A	DWS Contrast?	N/A
			N/A	DWS Length (in)	N/A
			N/A	DWS Full Width?	N/A
			N/A	DWS Offset (in)	N/A
			N/A	Shared Landing?	N/A
			N/A	Gutter Ponding?	N/A
			N/A	Gutter Lip Ht (in)	N/A
			N/A	Painted X Walk1?	No
				X Walk 1 Direction	To SW
			N/A	X Walk 1 Width (in)	N/A
				X Walk 1 Slope (%)	1.1

X Walk 1 X Slope (%)	3.1
			N/A	Ramp inside XWalk1?	N/A
			N/A	Road Slope (%)	N/A
			N/A	Road X Slope (%)	N/A
			N/A	Any Obstructions?	N/A
				Obstruction Type	
Total Cost:		\$ 1850.00			
			N/A		N/A
			Yes	Surface Condition? (G/P)	Good
