# Access Compliance Report

## Public Rights-of-Way

### (Curb Ramps)

Intersection ID: 28768	Main Street: FOUNTAINGROVE_DR	Cross Street: MAYCROFT_DR	Location: E
ADA ID: EE80396DEF01	Ramp Type: Perp	Initial Pass/Fail: Fail	Overall Compliance: No
Severity Score: 33.75			
Codes/Mitigation Info/Possible Solution		Field Measurements/Component Compliance

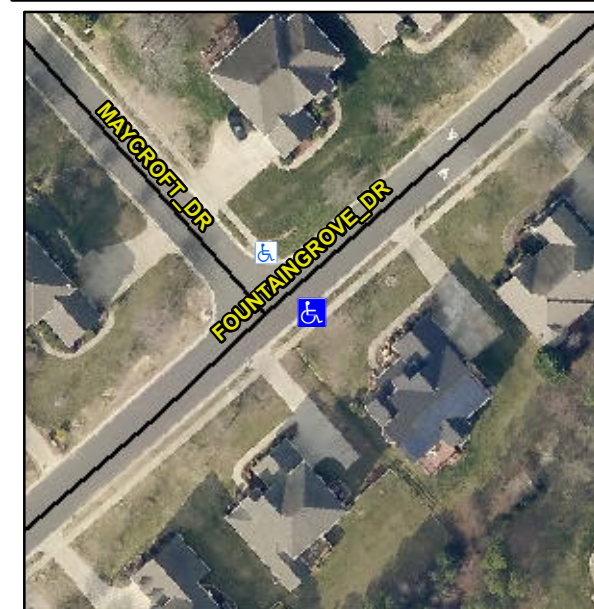
Compliance	Description	Data	Compliance	Description	Data
N/A	Ramp Length (in)	48.0	No	Ramp Slope (%)	12.9
No	Ramp Width (in)	42.0	Yes	Ramp XSlope (%)	0.4
N/A	Flare Type LT	N/A	N/A	Flare Type RT	N/A
N/A	Flare Slope LT (%)	N/A	N/A	Flare Slope RT (%)	N/A
N/A	Flare Traversable LT?	N/A	N/A	Flare Traversable RT?	N/A
N/A	Landing Length (in)	N/A	N/A	DWS Provided?	N/A
N/A	Landing Width (in)	N/A	N/A	DWS Contrast?	N/A
N/A	Landing Slope (%)	N/A	N/A	DWS Length (in)	N/A
N/A	Landing X Slope (%)	N/A	N/A	DWS Full Width?	N/A
N/A	Landing Curb? (Y/N)	N/A	N/A	DWS Offset (in)	N/A
N/A	Shared Landing?	N/A			
N/A	Gutter Ponding?	N/A	N/A	Gutter Slope (%)	N/A
N/A	Gutter Lip Ht (in)	N/A	N/A	Gutter X Slope (%)	N/A
N/A	Painted X Walk1?	No	N/A	Painted X Walk2?	N/A
	X Walk 1 Direction	To NW		X Walk 2 Direction	N/A
N/A	X Walk 1 Width (in)	N/A	N/A	X Walk 2 Width (in)	N/A
	X Walk 1 Slope (%)	2.3		X Walk 2 Slope (%)	N/A
	X Walk 1 X Slope (%)	1.9		X Walk 2 X Slope (%)	N/A

N/A	Ramp inside XWalk1?	N/A	N/A	Ramp inside XWalk2?	N/A
	Road Slope (%)	N/A	N/A	Clear Space?	N/A
	Road X Slope (%)	N/A	N/A	Clear Space to XWalk (in)	N/A
N/A	Any Obstructions?	N/A	N/A	Storm Grate/Utility Hazard?	N/A
	Obstruction Type			Storm Grate/Utility Type	
		N/A			N/A
			Yes	Surface Condition? (G/P)	Good

Possible Solutions:

**Remove & Replace Entire Ramp.**

**R304.5.1, R304.2.2**

Total Cost: \$ 1850.00
