ADA ID: EE8BD0677884

Access Compliance Report Public Rights-of-Way (Curb Ramps)

Main Street: CLANTON RD **Cross Street: S TRYON ST** Location: Intersection ID: 15725 SW Initial Pass/Fail: Fail **Overall Compliance: No**

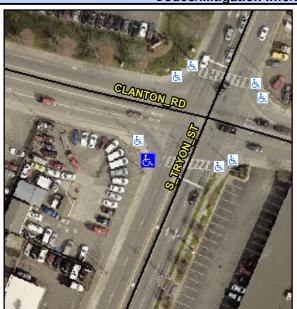
1 CSSIBIC COIGUION			icia ilic
Possible Solutions:	Compli	ance Des	cription
Remove & Replace Entire Ramp.	N/A	Ramp Len	gth (in)
·	Yes	Ramp Wid	th (in)
	N/A	Flare Type	tT
	N/A	Flare Slop	e LT (%)
	N/A	Flare Trav	ersable L1
	N/A	Landing Lo	ength (in)
Surveyor Notes:	N/A	Landing W	/idth (in)
N/A	N/A	Landing S	lope (%)
	N/A	Landing X	Slope (%)
	N/A	Landing C	urb? (Y/N
	N/A	Shared La	nding?
PROW/ADA:	N/A	Gutter Por	nding?
Not Found, R304.2.2, R304.5.3	N/A	Gutter Lip	Ht (in)
	N/A	Painted X	Walk1?
		X Walk 1 [Direction
	N/A	X Walk 1 \	Vidth (in)
		X Walk 1 S	Slope (%)
		X Walk 1 X	Slope (%
	N/A	Ramp insi	de XWalk′
		Road Slop	e (%)
