## Access Compliance Report Public Rights-of-Way (Curb Ramps)

•							
Intersection ID: 29389 Main Street: GOLD_PAN_RD				Cross Street: REEDY_PLANTATION_RD				Location:	SE	
ADA ID: EE92BE5A766	ID: EE92BE5A7666 Ramp Type: PerpDiag			nitial Pass/Fail: Fail Overall Compliance: No			o Severity Score:	22.5		
Codes/Mitigation Info/Possible Solution					Field Measurements/Component Compliance

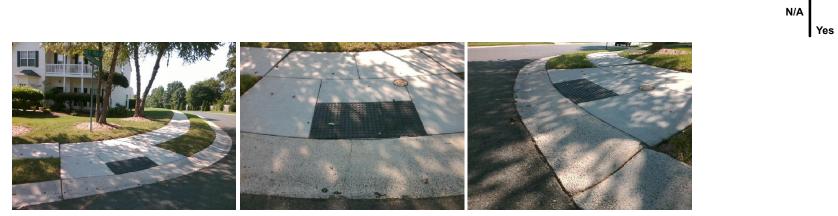
6. 1 1	in the	Possible Solutions:		Compliance Description		Data	Data Compliance Description		Data	
		Remove & Replace Curb Ra	mp With	N/A	Ramp Length (in)	48.5	No	Ramp Slope (%)	9.2	
		Two New Directional Ramps		No	Ramp Width (in)	47.5	No	Ramp XSlope (%)	4.9	
		Equivalent.		N/A	Flare Type LT	N/A	N/A	Flare Type RT	N/A	
				N/A	Flare Slope LT (%)	N/A	N/A	Flare Slope RT (%)	N/A	
				N/A	Flare Traversable LT?	N/A	N/A	Flare Traversable RT?	N/A	
	TID PAN RD			N/A	Landing Length (in)	N/A	N/A	DWS Provided?	N/A	
		Surveyor Notes:		N/A	Landing Width (in)	N/A	N/A	DWS Contrast?	N/A	
		N/A		N/A	Landing Slope (%)	N/A	N/A	DWS Length (in)	N/A

6.	I ame Carlo T	10/2		N/A	Landing X Slope (%)	N/A	N/A	DWS Full Width?	N/A	
			N/A	Landing Curb? (Y/N)	N/A	N/A	DWS Offset (in)	N/A		
	10 - di			N/A	Shared Landing?	N/A				
		PROW/ADA:		N/A	Gutter Ponding?	N/A	N/A	Gutter Slope (%)	N/A	
	the state of	Not Found, R304.5.1, R304.2.2,	<b>.</b>	N/A	Gutter Lip Ht (in)	N/A	N/A	Gutter X Slope (%)	N/A	
		R304.5.3	2.2,	N/A	Painted X Walk1?	No	N/A	Painted X Walk2?	No	
	1004.0.0		N/A	X Walk 1 Direction	To N		X Walk 2 Direction	To W		
ACE SCIAN			N/A	X Walk 1 Width (in)	N/A	N/A	X Walk 2 Width (in)	N/A		
Street 1 Name	Name GOLD PAN RD			N/A			IN/A			
					X Walk 1 Slope (%)	0.4 4.0		X Walk 2 Slope (%)	5.5	
Stop Condition-Street 2 Street 2 Name	StopSign REEDY PLANTATION RD			<b>NI/A</b>	X Walk 1 X Slope (%)	-		X Walk 2 X Slope (%)	3.1	
				N/A	Ramp inside XWalk1?	N/A	N/A	Ramp inside XWalk2?	N/A	
Stop Condition-Street 1	None				Road Slope (%)	5.1	N/A	Clear Space?	N/A

Road X Slope (%)	3.0	N/A	Clear Space to XWalk (in)	N/A	
				N/A	Any Obstructions?	N/A	N/A	Storm Grate/Utility Hazard?	N/A	
		Total Cost: \$	3200.00		Obstruction Type			Storm Grate/Utility Type		
						N/A			N/A
