Access Compliance Report

Public Rights-of-Way (Curb Ramps)

Intersection ID: 8522	Main Street: MARBLE_ST	Cross Street: WILLARD_ST	Location: W
ADA ID: EE935B7BABFC	Ramp Type: Directional1	Initial Pass/Fail: Fail	Overall Compliance: No
Severity Score: 1.25			
Codes/Mitigation Info/Possible Solution		Field Measurements/Component Compliance

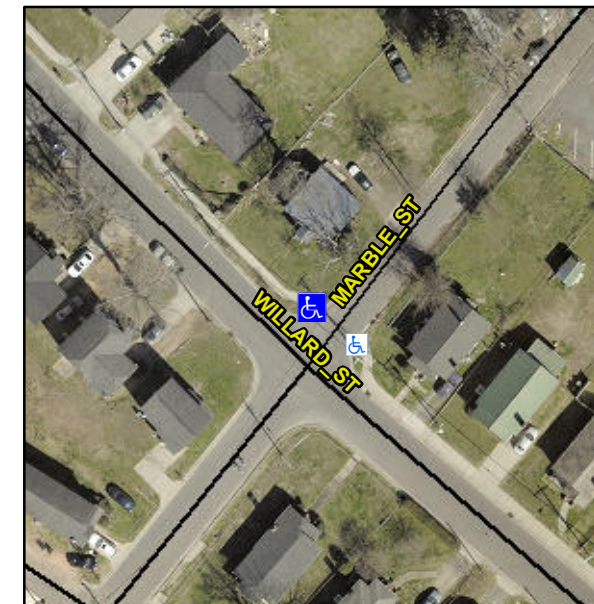
Compliance	Description	Data	Compliance	Description	Data
N/A	Ramp Length (in)	87.0	N/A	Grade Break?	N/A
Yes	Ramp Width (in)	65.5	N/A	Grade Break Slope (%)	0.0
Yes	Ramp Slope (%)	5.7	N/A	Grade Break XSlope (%)	0.0
No	Ramp XSlope (%)	2.3			
N/A	Flare Type LT	N/A	N/A	Flare Type RT	N/A
N/A	Flare Slope LT (%)	N/A	N/A	Flare Slope RT (%)	0.0
N/A	Flare Traversable LT?	N/A	N/A	Flare Traversable RT?	N/A
N/A	Landing Length (in)	0.0	N/A	DWS Provided?	N/A
N/A	Landing Width (in)	0.0	N/A	DWS Contrast?	N/A
N/A	Landing Slope (%)	0.0	N/A	DWS Length (in)	N/A
N/A	Landing X Slope (%)	0.0	N/A	DWS Full Width?	N/A
N/A	Landing Curb? (Y/N)	N/A	N/A	DWS Offset LT (in)	N/A
N/A	Shared Landing?	N/A	N/A	DWS Offset RT (in)	N/A
N/A	Gutter Ponding?	0.0	N/A	Gutter Slope (%)	N/A
N/A	Gutter Lip Ht (in)	0.0	N/A	Gutter X Slope (%)	N/A
N/A	Painted X Walk1?	No		Road Slope (%)	2.4
	X Walk 1 Direction	To NE		Road X Slope (%)	1.2
	X Walk 1 Width (in)	N/A		Clear Space?	N/A

X Walk 1 Slope (%)	2.4	N/A	Clear Space to XWalk (in)	N/A
	X Walk 1 X Slope (%)	1.2	N/A	Storm Grate/Utility Hazard?	N/A
N/A	Ramp inside XWalk1?	N/A		Storm Grate/Utility Type	
N/A	Any Obstructions?	N/A			N/A
	Obstruction Type		Yes	Surface Condition? (G/P)	Good
			N/A	Curb Slope (%)	10.7

Possible Solutions:

Remove & Replace Entire Ramp.

R304.5.3
