Access Compliance Report Public Rights-of-Way (Curb Ramps)

Intersection ID: N/AMain Street: ROGALLA_DRCross Street: N/ALocation:NADA ID: EE979A890B85Ramp Type: PerpInitial Pass/Fail: PassOverall Compliance: NoSeverity Score:15

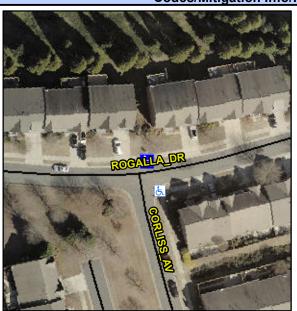
Field Measurements/Component Compliance						
Compl	iance Description	Data	Comp	liance Description	Data	
N/A	Ramp Length (in)	48.0	Yes	Ramp Slope (%)	7.1	
Yes	Ramp Width (in)	48.0	Yes	Ramp XSlope (%)	1.6	
N/A	Flare Type LT	None	N/A	Flare Type RT	N/A	
N/A	Flare Slope LT (%)	N/A	N/A	Flare Slope RT (%)	N/A	
N/A	Flare Traversable LT?	N/A	N/A	Flare Traversable RT?	N/A	
Yes	Landing Length (in)	60.0	No	DWS Provided?	No	
Yes	Landing Width (in)	48.0	N/A	DWS Contrast?	No	
No	Landing Slope (%)	2.8	N/A	DWS Length (in)	N/A	
Yes	Landing X Slope (%)	0.4	N/A	DWS Full Width?	No	
N/A	Landing Curb? (Y/N)	No	N/A	DWS Offset (in)	N/A	
N/A	Shared Landing?	No				
Yes	Gutter Ponding?	No	No	Gutter Slope (%)	5.9	
Yes	Gutter Lip Ht (in)	0.0	No	Gutter X Slope (%)	2.3	
N/A	Painted X Walk1?	No	N/A	Painted X Walk2?	N/A	
	X Walk 1 Direction	To S		X Walk 2 Direction	N/A	
N/A	X Walk 1 Width (in)	N/A	N/A	X Walk 2 Width (in)	N/A	
	X Walk 1 Slope (%)	2.7		X Walk 2 Slope (%)	N/A

X Walk 1 X Slope (%)	1.4		X Walk 2 X Slope (%)	N/A	
N/A	Ramp inside XWalk1?	N/A	N/A	Ramp inside XWalk2?	N/A	
	Road Slope (%)	N/A	N/A	Clear Space?	Yes	
	Road X Slope (%)	N/A	N/A	Clear Space to XWalk (in)	N/A	
Yes	Any Obstructions?	No	Yes	Storm Grate/Utility Hazard?	No	
	Obstruction Type			Storm Grate/Utility Type		
		N/A			N/A	
			Yes	Surface Condition? (G/P)	Good

/Possible Solution	
Possible Solutions:	Cor
Remove & Replace Entire Ramp.	N/A
Remove & Replace Gutter.	Yes
	N/A
	N/A
	N/A
	Yes
Surveyor Notes:	Yes
N/A	No
	Yes
	N/A
	N/A
PROW/ADA:	Yes
R304.2.2-Perp, R304.3.2-Para, R305,	Yes
R304.5.4, R304.5.3	N/A
	N/A
	N/A

Total Cost:	\$ 2600.00
