Access Compliance Report

Public Rights-of-Way

(Curb Ramps)

| Intersection ID: 10025682 | Main Street: EAST_BV | Cross Street: N/A | Location: SW |

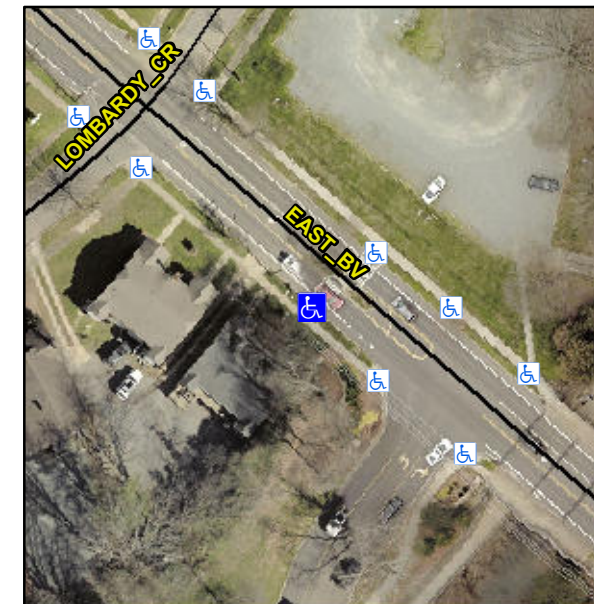
| ADA ID: EE9E7946430D | Ramp Type: Perp | Initial Pass/Fail: Fail | Overall Compliance: No |

R304.2.2

| Compliance | Description | Data | Compliance | Description | Data |
|---|---|---|---|---|---|
| N/A | Ramp Length (in) | 61.0 | No | Ramp Slope (%) | 9.0 |

Remove & Replace Entire Ramp.
