## Access Compliance Report Public Rights-of-Way (Curb Ramps)

Intersection ID: 3920 Main Street: OVERLOOK_MOUNTAIN_DR				Cross Street: OVERLOOK_COVE_RD				Location:	NE
ADA ID: EEA1A849FC06 Ramp Type: Perp			initial P	Initial Pass/Fail: Fail Overall Compliance: No					12.5
Codes/Mitigation Info/Possible Solution				Field Measurements/Component Compliance					
		Possible Solutions:		Compliance Description			Data Compliance Description		
		Remove & Replace Entire Ramp		N/A	Ramp Length (in)	94.0	No	Ramp Slope (%)	8.9
				Yes	Ramp Width (in)	48.0	Yes	Ramp XSlope (%)	0.8
94	Martin Contraction			N/A	Flare Type LT	N/A	N/A	Flare Type RT	N/A
A LEE S AND				N/A	Flare Slope LT (%)	N/A	N/A	Flare Slope RT (%)	N/A
1002				N/A	Flare Traversable LT?	N/A	N/A	Flare Traversable RT?	N/A
				N/A	Landing Length (in)	N/A	N/A	DWS Provided?	N/A
A CONTRACTOR		Surveyor Notes:		N/A	Landing Width (in)	N/A	N/A	DWS Contrast?	N/A
the second se	A BO	N/A		N/A	Landing Slope (%)	N/A	N/A	DWS Length (in)	N/A

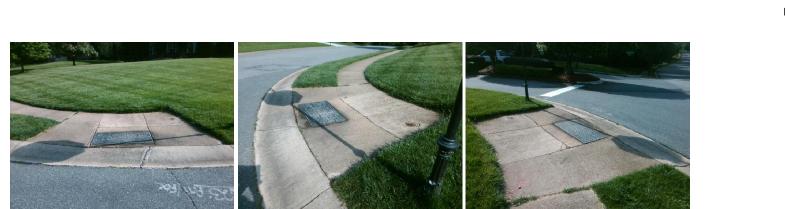
d.	118.3	Not Found, R304.2.2		N/A	Gutter Lip Ht (in)	N/A	N/A	Gutter X Slope (%)	N/A
		· · · · · · · · · · · · · · · · · · ·		N/A	Painted X Walk1?	No	N/A	Painted X Walk2?	N/A
					X Walk 1 Direction	To SE		X Walk 2 Direction	N/A
				N/A	X Walk 1 Width (in)	N/A	N/A	X Walk 2 Width (in)	N/A
Street 1 Name	OVERLOOK COVE RD				X Walk 1 Slope (%)	4.9		X Walk 2 Slope (%)	N/A
Stop Condition-Street 2	StopSign				X Walk 1 X Slope (%)	0.6		X Walk 2 X Slope (%)	N/A
Street 2 Name	N/A			N/A	Ramp inside XWalk1?	N/A	N/A	Ramp inside XWalk2?	N/A
Stop Condition-Street 1	N/A				Road Slope (%)	N/A	N/A	Clear Space?	N/A
					Road X Slope (%)	N/A	N/A	Clear Space to XWalk (in)	N/A
				N/A	Any Obstructions?	N/A	N/A	Storm Grate/Utility Hazard?	N/A
		Total Cost: \$	1850.00		Obstruction Type			Storm Grate/Utility Type	
						N/A			N/A
