Access Compliance Report

Public Rights-of-Way

(Curb Ramps)

Intersection ID: N/A	Main Street: HORACE_ST	Cross Street: N/A	Location: SE
ADA ID: EEA370C3CD6F	Ramp Type: Perp	Initial Pass/Fail: Fail	Overall Compliance: No
		Severity Score: 12.5

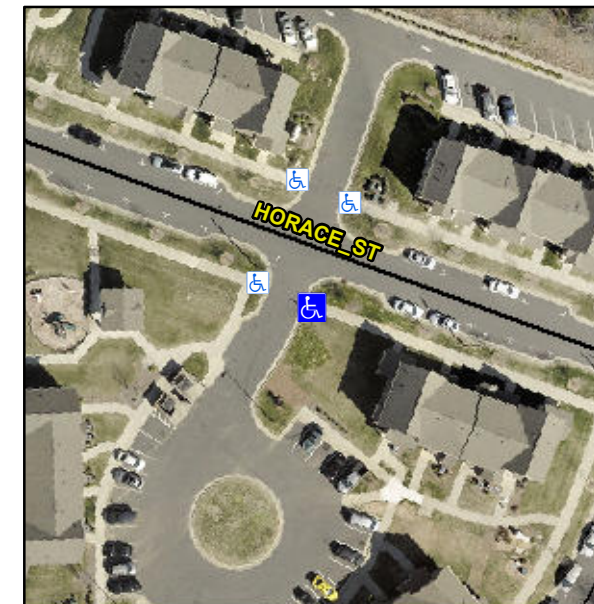
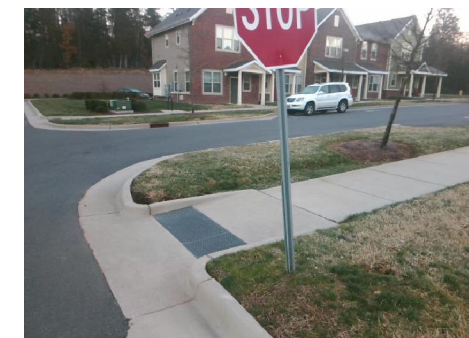
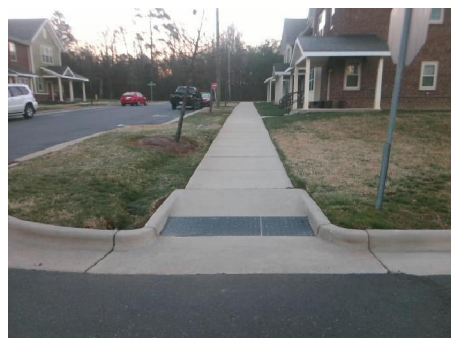
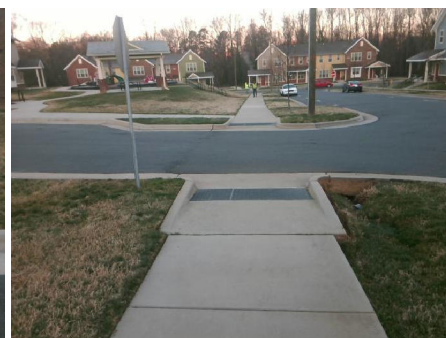
Compliance	Description	Data	Compliance	Description	Data
N/A	Ramp Length (in)	72.5	No	Ramp Slope (%)	9.1
Yes	Ramp Width (in)	71.0	Yes	Ramp XSlope (%)	0.9
N/A	Flare Type LT	N/A	N/A	Flare Type RT	N/A
N/A	Flare Slope LT (%)	N/A	N/A	Flare Slope RT (%)	N/A
N/A	Flare Traversable LT?	N/A	N/A	Flare Traversable RT?	N/A
N/A	Landing Length (in)	N/A	N/A	DWS Provided?	N/A
N/A	Landing Width (in)	N/A	N/A	DWS Contrast?	N/A
N/A	Landing Slope (%)	N/A	N/A	DWS Length (in)	N/A
N/A	Landing X Slope (%)	N/A	N/A	DWS Full Width?	N/A
N/A	Landing Curb? (Y/N)	N/A	N/A	DWS Offset (in)	N/A
N/A	Shared Landing?	N/A			
N/A	Gutter Ponding?	N/A	N/A	Gutter Slope (%)	N/A
N/A	Gutter Lip Ht (in)	N/A	N/A	Gutter X Slope (%)	N/A
N/A	Painted X Walk1?	No	N/A	Painted X Walk2?	N/A
	X Walk 1 Direction	To NW		X Walk 2 Direction	N/A
N/A	X Walk 1 Width (in)	N/A	N/A	X Walk 2 Width (in)	N/A
	X Walk 1 Slope (%)	4.0		X Walk 2 Slope (%)	N/A
	X Walk 1 X Slope (%)	1.8		X Walk 2 X Slope (%)	N/A

Remove & Replace Entire Ramp.
