Access Compliance Report Public Rights-of-Way (Curb Ramps)

Street 1 Name
Stop Condition-Street 1
Street 2 Name
Stop Condition-Street 2

MAPLECREST DR StopSign BRIARDALE DR None Possible Solutions:

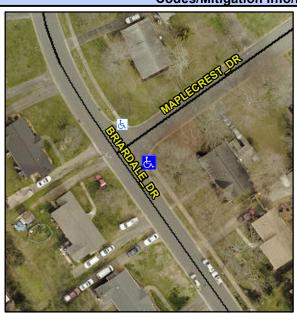
Surveyor Notes:

ASP LIP 1.0

PROW/ADA:

R304.5.1

Compliance Description Data		Compliance Description		Data	
N/A	Ramp Length (in)	57.0	Yes	BlendTrans Slope (%)	3.2
No	Ramp Width (in)	47.0	Yes	BlendTrans XSlope (%)	1.8
N/A	Flare Type LT	N/A	N/A	Flare Type RT	N/A
N/A	Flare Slope LT (%)	N/A	N/A	Flare Slope RT (%)	N/A
N/A	Flare Traversable LT?	N/A	N/A	Flare Traversable RT?	N/A
N/A	Landing Length (in)	N/A	N/A	DWS Provided?	N/A
N/A	Landing Width (in)	N/A	N/A	DWS Contrast?	N/A
N/A	Landing Slope (%)	N/A	N/A	DWS Length (in)	N/A
N/A	Landing X Slope (%)	N/A	N/A	DWS Full Width?	N/A
N/A	Landing Curb? (Y/N)	N/A	N/A	DWS Offset (in)	N/A
N/A	Shared Landing?	N/A			
N/A	Gutter Ponding?	N/A	N/A	Gutter Slope (%)	N/A
N/A	Gutter Lip Ht (in)	N/A	N/A	Gutter X Slope (%)	N/A
N/A	Painted X Walk1?	No	N/A	Painted X Walk2?	No
	X Walk 1 Direction	To NW		X Walk 2 Direction	To SW
	X Walk 1 Width (in)	N/A		X Walk 2 Width (in)	N/A
	X Walk 1 Slope (%)	2.9		X Walk 2 Slope (%)	1.2
	X Walk 1 X Slope (%)	1.1		X Walk 2 X Slope (%)	2.8

N/A	Ramp inside XWalk1?	N/A	N/A	Ramp inside XWalk2?	N/A
	Road Slope (%)	0.5		Clear Space?	N/A
	Road X Slope (%)	3.5	N/A	Clear Space to XWalk (in)	N/A
N/A	Any Obstructions?	N/A	N/A	Storm Grate/Utility Hazard?	N/A
	Obstruction Type		l	Storm Grate/Utility Type	
		N/A			N/A
			Yes	Surface Condition? (G/P)	Good
			N/A	Curb Slope (%)	0.9

Remove & Replace Curb Ramp With Two New Directional Ramps or Equivalent.

Total Cost: \$ 3200.00
