# Access Compliance Report

## Public Rights-of-Way

Intersection ID: 7277	Main Street: NORTHRIDGE_VILLAGE_DR	Cross Street: TOM_HUNTER_RD	Location: NE
ADA ID: EEAC2A46A8DC	Ramp Type: ParaDiag	Initial Pass/Fail: Fail	Overall Compliance: No
Severity Score: 25			
Codes/Mitigation Info/Possible Solution		Field Measurements/Component Compliance

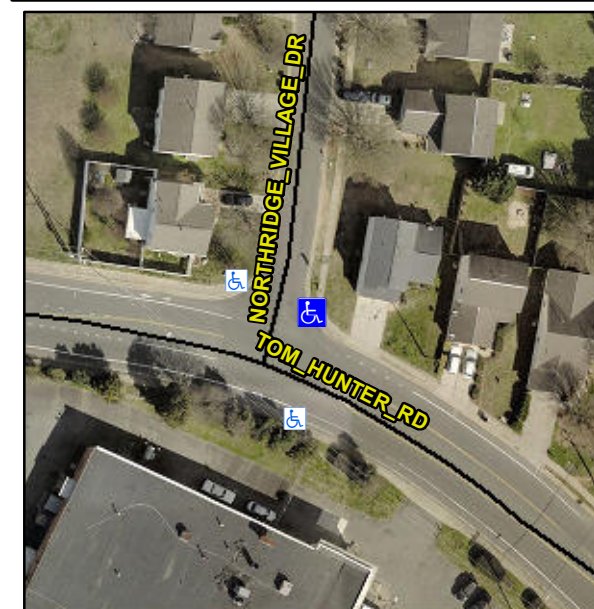
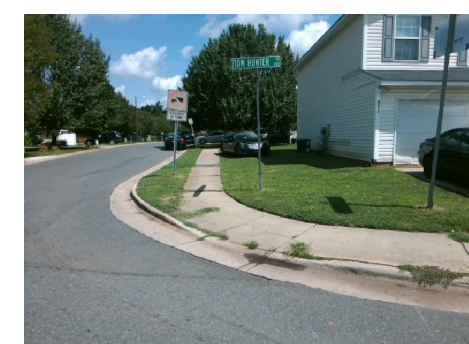
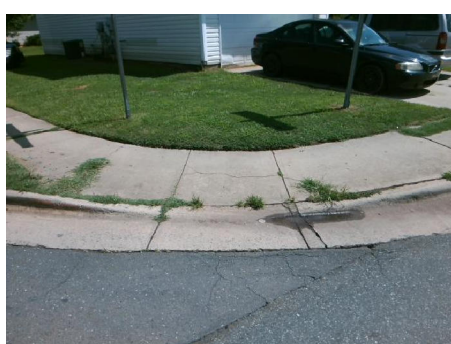
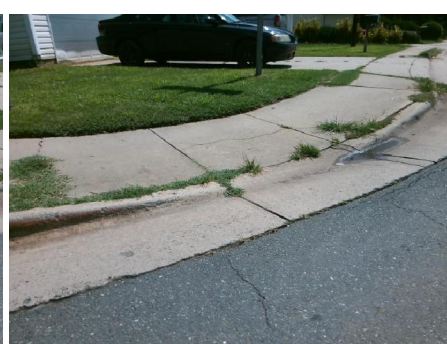
**VEGETATION OVERGROWTH, RT  
RP < 5%**

**R304.5.3**

Compliance	Description	Data	Compliance	Description	Data
N/A	Ramp Length LT (in)	64.0	N/A	Ramp Length RT (in)	44.0
Yes	Ramp Width LT (in)	52.0	Yes	Ramp Width RT (in)	58.0
Yes	Ramp Slope LT (%)	8.1	Yes	Ramp Slope RT (%)	3.9
No	Ramp XSlope LT (%)	6.0	No	Ramp XSlope RT (%)	8.3
N/A	Landing Length (in)	N/A	N/A	DWS Provided?	N/A
N/A	Landing Width (in)	N/A	N/A	DWS Contrast?	N/A
N/A	Landing Slope (%)	N/A	N/A	DWS Length (in)	N/A
N/A	Landing X Slope (%)	N/A	N/A	DWS Full Width?	N/A
N/A	Landing Curb? (Y/N)	N/A	N/A	DWS Offset (in)	N/A
N/A	Shared Landing?	N/A			
N/A	Gutter Ponding?	N/A	N/A	Gutter Slope (%)	N/A
N/A	Gutter Lip Ht (in)	N/A	N/A	Gutter X Slope (%)	N/A
N/A	Painted X Walk1?	No	N/A	Painted X Walk2?	No
	X Walk 1 Direction	To W		X Walk 2 Direction	To S
N/A	X Walk 1 Width (in)	N/A	N/A	X Walk 2 Width (in)	N/A
	X Walk 1 Slope (%)	0.1		X Walk 2 Slope (%)	0.8
	X Walk 1 X Slope (%)	1.8		X Walk 2 X Slope (%)	0.8
N/A	Ramp inside XWalk1?	N/A	N/A	Ramp inside XWalk2?	N/A

Road Slope (%)	3.2	N/A	Clear Space?	N/A
	Road X Slope (%)	4.5	N/A	Clear Space to XWalk (in)	N/A
N/A	Any Obstructions?	N/A	N/A	Storm Grate/Utility Hazard?	N/A
	Obstruction Type			Storm Grate/Utility Type	
		N/A			N/A
			Yes	Surface Condition? (G/P)	Good
			N/A	Curb Slope (%)	20.3

**Remove & Replace Curb Ramp With Two New Directional Ramps or Equivalent.**
