Access Compliance Report

Public Rights-of-Way

(Curb Ramps)

Intersection ID: 10027733	Main Street: GRIFFITH_ST	Cross Street: N/A	Location: N
ADA ID: EEB46C205A38	Ramp Type: PerpDiag	Initial Pass/Fail: Fail	Overall Compliance: No
Severity Score: 22.5			
Codes/Mitigation Info/Possible Solution		Field Measurements/Component Compliance

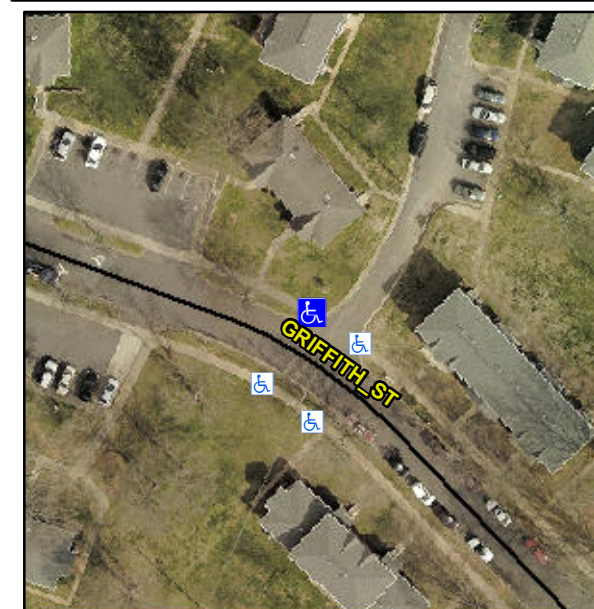
Not Found, R304.5.1, R304.2.2, R304.5.3

Compliance	Description	Data	Compliance	Description	Data
N/A	Ramp Length (in)	80.0	No	Ramp Slope (%)	8.7
No	Ramp Width (in)	45.0	No	Ramp XSlope (%)	3.1
N/A	Flare Type LT	N/A	N/A	Flare Type RT	N/A
N/A	Flare Slope LT (%)	N/A	N/A	Flare Slope RT (%)	N/A
N/A	Flare Traversable LT?	N/A	N/A	Flare Traversable RT?	N/A
N/A	Landing Length (in)	N/A	N/A	DWS Provided?	N/A
N/A	Landing Width (in)	N/A	N/A	DWS Contrast?	N/A
N/A	Landing Slope (%)	N/A	N/A	DWS Length (in)	N/A
N/A	Landing X Slope (%)	N/A	N/A	DWS Full Width?	N/A
N/A	Landing Curb? (Y/N)	N/A	N/A	DWS Offset (in)	N/A
N/A	Shared Landing?	N/A			
N/A	Gutter Ponding?	N/A	N/A	Gutter Slope (%)	N/A
N/A	Gutter Lip Ht (in)	N/A	N/A	Gutter X Slope (%)	N/A
N/A	Painted X Walk1?	No	N/A	Painted X Walk2?	No
	X Walk 1 Direction	To SW		X Walk 2 Direction	To SE
N/A	X Walk 1 Width (in)	N/A	N/A	X Walk 2 Width (in)	N/A
	X Walk 1 Slope (%)	1.5		X Walk 2 Slope (%)	2.5
	X Walk 1 X Slope (%)	2.1		X Walk 2 X Slope (%)	1.0

N/A	Ramp inside XWalk1?	N/A	N/A	Ramp inside XWalk2?	N/A
	Road Slope (%)	1.3	N/A	Clear Space?	N/A
	Road X Slope (%)	5.0	N/A	Clear Space to XWalk (in)	N/A
N/A	Any Obstructions?	N/A	N/A	Storm Grate/Utility Hazard?	N/A
	Obstruction Type			Storm Grate/Utility Type	
		N/A			N/A
			Yes	Surface Condition? (G/P)	Good

Possible Solutions:

Remove & Replace Curb Ramp With Two New Directional Ramps or Equivalent.
