Access Compliance Report

Public Rights-of-Way

(Curb Ramps)

Intersection ID: 2934	Main Street: CHINQUAPIN_CT	Cross Street: LADY_BANK_DR	Location: NW
ADA ID: EEBE115CD548	Ramp Type: PerpDiag	Initial Pass/Fail: Fail	Overall Compliance: No
Severity Score: 12.5			
Codes/Mitigation Info/Possible Solution		Field Measurements/Component Compliance

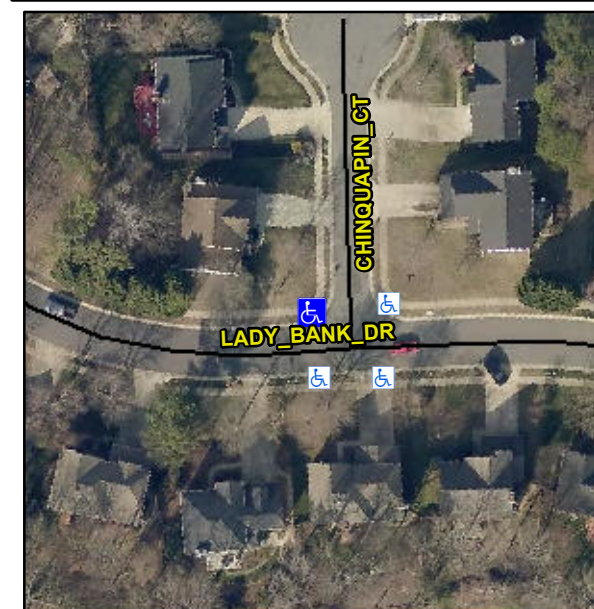
Not Found, R304.2.2

Compliance	Description	Data	Compliance	Description	Data
N/A	Ramp Length (in)	37.0	No	Ramp Slope (%)	8.6
Yes	Ramp Width (in)	137.0	Yes	Ramp XSlope (%)	1.5
N/A	Flare Type LT	N/A	N/A	Flare Type RT	N/A
N/A	Flare Slope LT (%)	N/A	N/A	Flare Slope RT (%)	N/A
N/A	Flare Traversable LT?	N/A	N/A	Flare Traversable RT?	N/A
N/A	Landing Length (in)	N/A	N/A	DWS Provided?	N/A
N/A	Landing Width (in)	N/A	N/A	DWS Contrast?	N/A
N/A	Landing Slope (%)	N/A	N/A	DWS Length (in)	N/A
N/A	Landing X Slope (%)	N/A	N/A	DWS Full Width?	N/A
N/A	Landing Curb? (Y/N)	N/A	N/A	DWS Offset (in)	N/A
N/A	Shared Landing?	N/A			
N/A	Gutter Ponding?	N/A	N/A	Gutter Slope (%)	N/A
N/A	Gutter Lip Ht (in)	N/A	N/A	Gutter X Slope (%)	N/A
N/A	Painted X Walk1?	No	N/A	Painted X Walk2?	No
	X Walk 1 Direction	To S		X Walk 2 Direction	To E
N/A	X Walk 1 Width (in)	N/A	N/A	X Walk 2 Width (in)	N/A
	X Walk 1 Slope (%)	5.5		X Walk 2 Slope (%)	2.7
	X Walk 1 X Slope (%)	2.8		X Walk 2 X Slope (%)	1.3

N/A	Ramp inside XWalk1?	N/A	N/A	Ramp inside XWalk2?	N/A
	Road Slope (%)	3.3	N/A	Clear Space?	N/A
	Road X Slope (%)	4.7	N/A	Clear Space to XWalk (in)	N/A
N/A	Any Obstructions?	N/A	N/A	Storm Grate/Utility Hazard?	N/A
	Obstruction Type			Storm Grate/Utility Type	
		N/A			N/A
		Yes		Surface Condition? (G/P)	Good

Possible Solutions:

Remove & Replace Curb Ramp With Two New Directional Ramps or Equivalent.
